# Comprehensive studies of pipes metal to identify the causes of failure in the gas pipeline of the gas lift system of an oil and gas condensate field

This article presents an approach to investigating one of a series of failures of a gas pipeline at a field in the Orenburg region, Russia. The failure was a pipe rupture, accompanied by a release of hydrogen sulfide-containing gas.

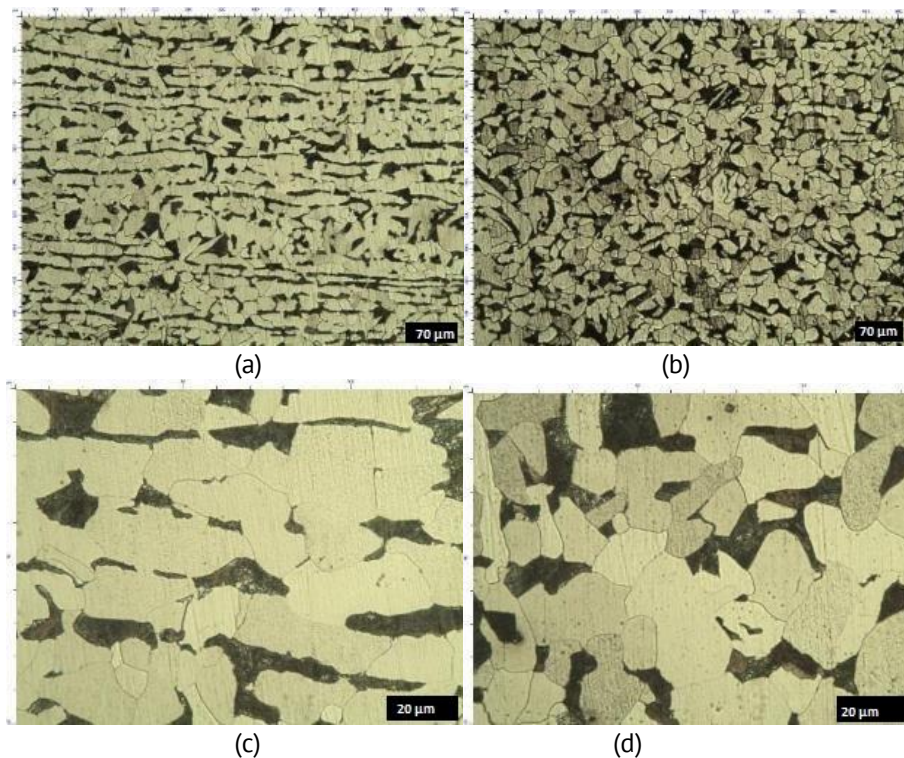
**Fig. 1.** Microstructure of fragments No. 2 (a,c) and No. 5 (b,d)

The microstructure of the studied fragments No. 2 and No. 5 is a combination of ferrite and pearlite. The ferrite grains in the microstructure of fragment No. 2 are more elongated along the rolling direction, compared to the structure of fragment No. 5. The distribution of microhardness along the cross-section of the pipe fragments No. 2 and No. 5 is shown in Fig. 2. The microhardness of fragments No. 2 and No. 5 is at the same level.

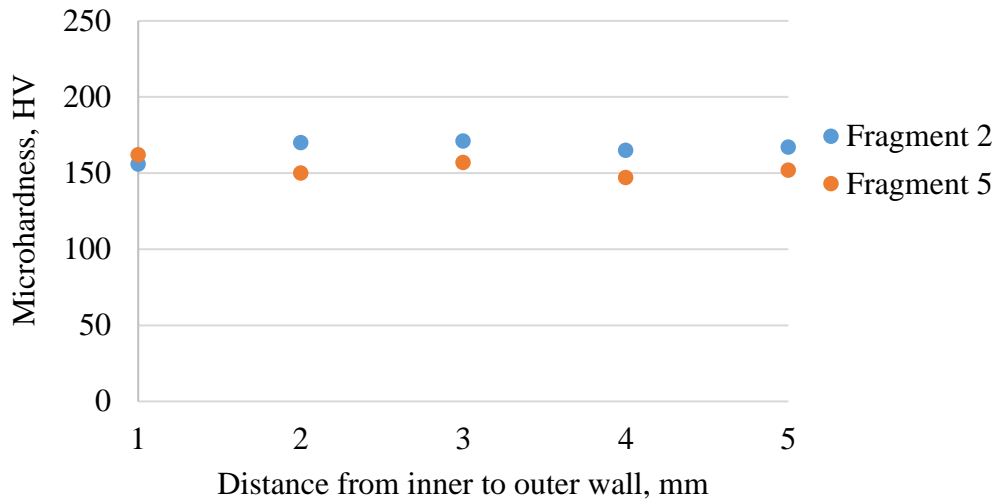
Fig. 2. The distribution of microhardness along the cross-section of the pipe

The microhardness level in the crack zone is higher compared to fragments No. 2 and No. 5 outside the crack zone. The obtained hardness values are shown in Table 2. The table shows that the hardness values of fragment No. 2 slightly exceed the hardness value of fragment No. 5.

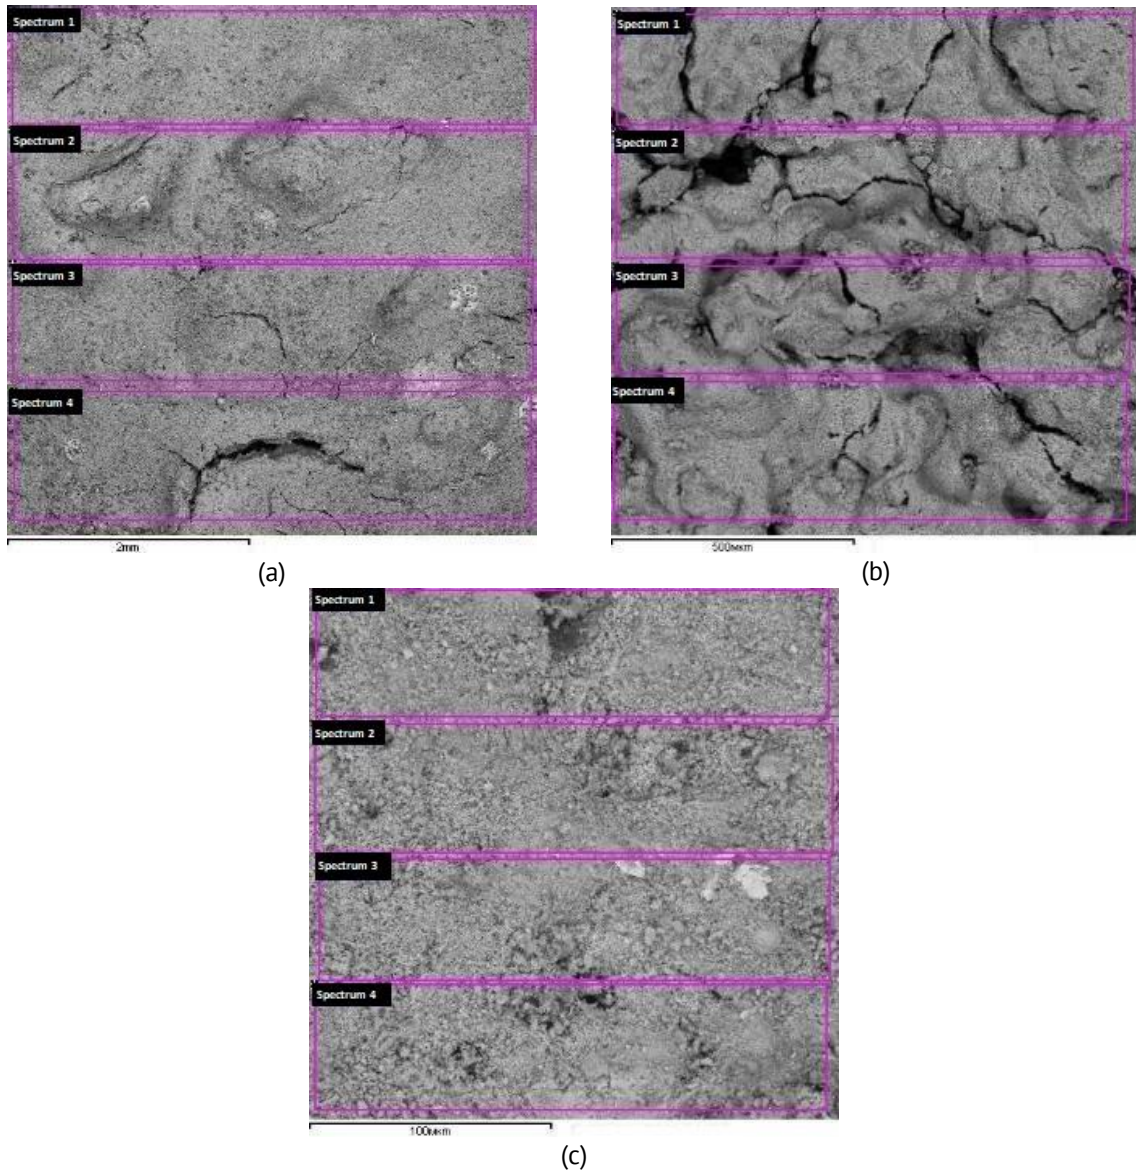
Fig. 3. Corrosion products of the studied fragments: (a) fragment No. 2, (b) fragment No. 5, (c) fragment No. 5 (in the crack area)

pipe fragment No. 5, the minimum wall thickness of the pipe in the crack area was 5.83 mm (with an initial wall thickness of 8 mm). To test the hypothesis of destruction occurrence due to corrosion, the chemical composition of the deposits was determined. The corrosion products are shown in Fig. 3.

The results of determining the chemical composition of the deposits revealed that the corrosion products of the studied fragments No. 2 and No. 5 mainly consist of Fe, O and S. In the crack area of pipe fragment No. 5, the corrosion products mainly include the elements Fe, Mn, Si, C, O, S and Ca.

According to the results of the analysis of corrosion products taken from the inner surface of the studied pipe fragments, the deposits mainly consist of iron and sulfur elements, which indicates that the corrosive agent is hydrogen sulfide contained in the transported wet gas.

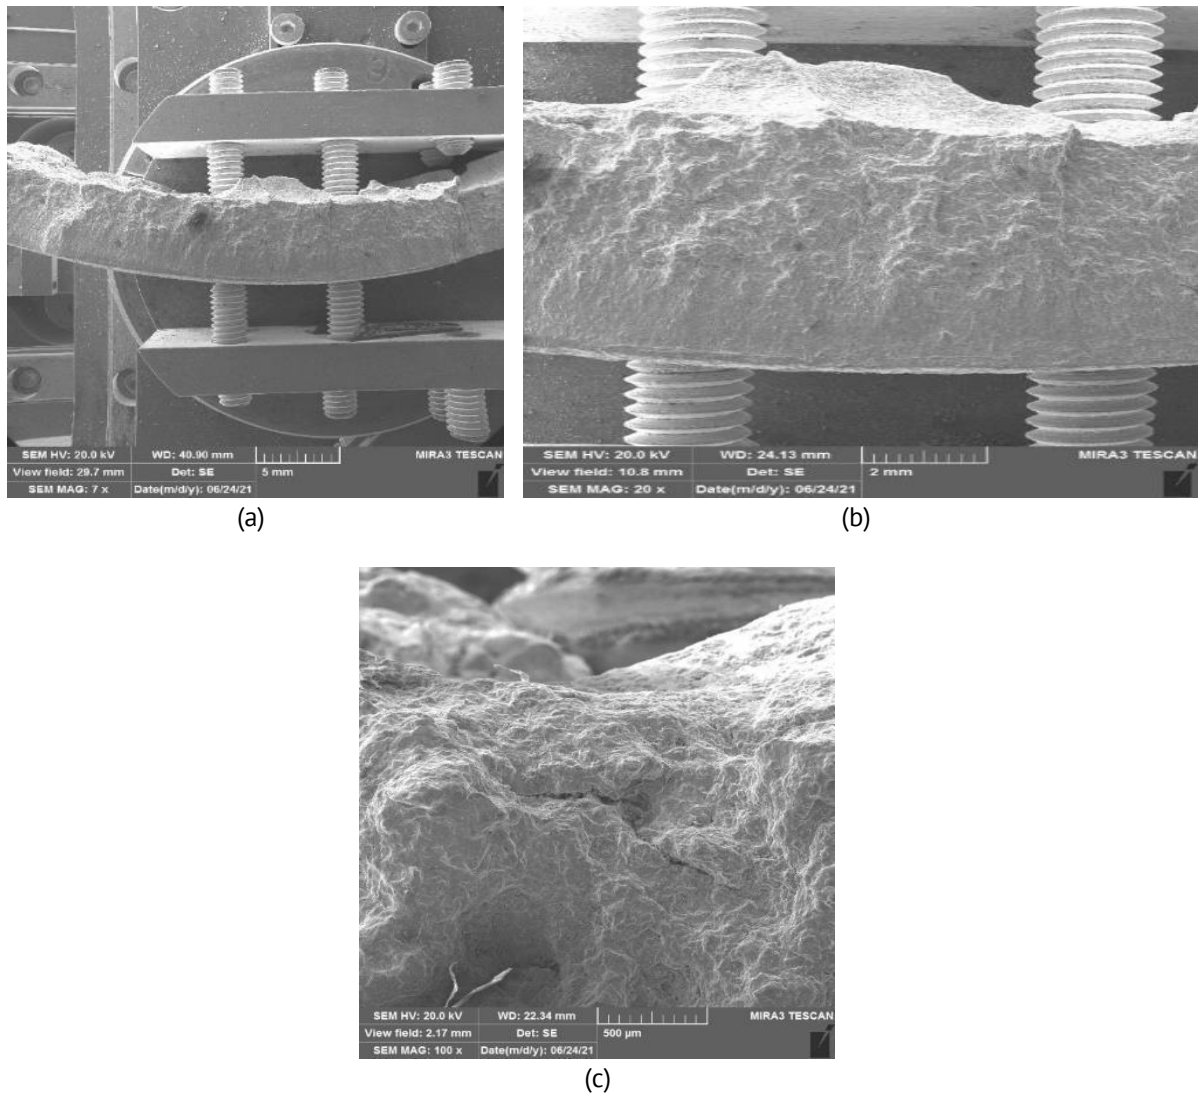
**Fig. 4.** External appearance of the fracture surface: (a) side view, (b) surface view, (c) fracture nature

After the removal of the corrosion products from the inner surface of the pipe fragment No. 5 and examination of the fracture surface using a scanning electron microscope, it was determined that the crack originated from the inner surface of the pipe, in addition, the presence of secondary cracks was revealed. Figure 4 shows the appearance of the fracture surface.

The analysis results showed that the crack was formed in a section without a weld. Thus, the most likely mechanism for crack occurrence is local thinning of the metal up to critical values (25 %) with possible hydrogenation as a result of  $H^+$  ions entering through corroded caverns.

Thus, the main cause of accelerated corrosion of pipe fragment No. 5 is the effect of wet gas containing carbon dioxide and hydrogen sulfide, which contribute to a decrease in the pH of the environment. As a result of corrosion, there was a thinning along the upper generatrix of the pipe up to a critical value, after which the initiation and growth of a crack to its through exit to the outside was observed [29].

As an emergency measure to protect gas pipelines of the gas lift system, it is recommended to use a corrosion inhibitor [30], which should be introduced using a spray nozzle or by periodic pumping in the form of a plug. The inhibitor should have high efficiency in the gas phase.

According to the conducted literature analysis [24], gas pipelines with flow rates of up to 3 m/s are at risk of possible corrosion along the upper generatrix of the pipe. To prevent water condensation along the upper generatrix, it is necessary to flush with liquid or increase the velocity of the transported gas. Thus, to reduce the localization of the corrosion process, an increase in gas flow rate is required to switch to the annular mode of a two-phase flow. If there is no possibility to increase the gas flow rate, it is recommended to reduce the diameter of the pipelines.
