STUDY OF THE INFLUENCE OF STRUCTURAL HERITAGE AND OPERATING CONDITIONS ON THE DURABILITY OF SAFETY VALVE SPRINGS FROM STEEL 50KHFA

Abstract. The reasons for the premature failure of a spring made of steel 50KhFA, which operated in the safety valve of the column's head part of the flare facility, were investigated using analytical chemistry, energy dispersive analysis, macro- and microstructural analysis, electron microscopy, macro- and electron fractography, phase chemical and X-ray structural analysis, hardness and microhardness tests and reductive heat treatment according to the regime recommended for safety valve springs in the standard process documentation and reference literature. The influence of non-metallic inclusions, such as carbides, their chemical composition, shape, and distribution on the operational properties of springs from steel 50KhFA has been investigated. Information on the characteristic external signs, typical micro damages, and the mechanism of destruction during low-temperature hydrogen sulfide corrosion of steel 50KhFA with the most dangerous accompanying process – hydrogenation was obtained. The analysis of the research results showed that the premature

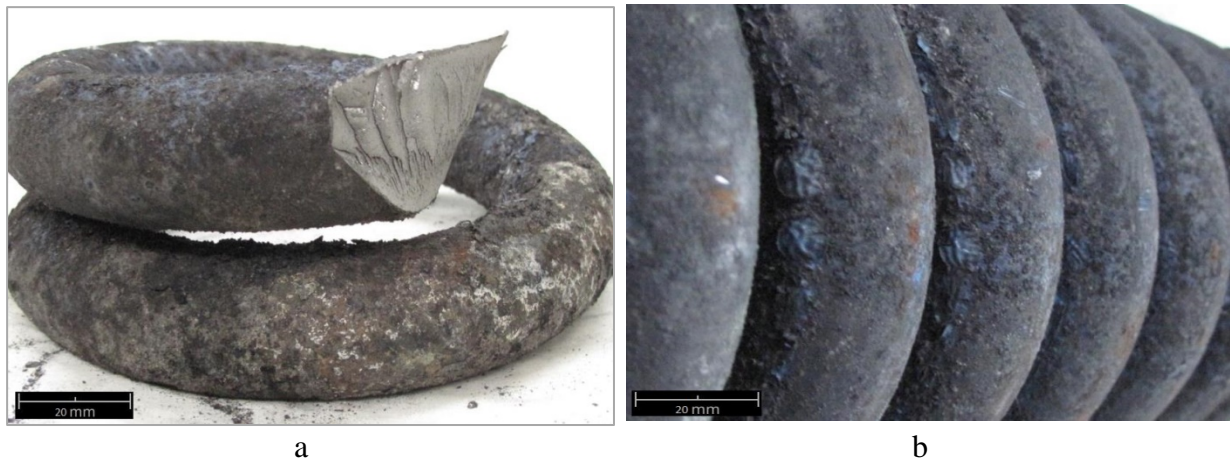
The investigated fragment of the spring is shown in Fig. 1a. Visual inspection showed that the number of spring turns, the outer diameter, the diameter of the rod, and other dimensions corresponded to the original parameters of the spring according to the manufacturer's specification. The protective coating on the surface of the spring was damaged in the form of swelling, flaking, side wear, and corrosion (Fig. 1b, 5).

Fig. 1. Fragment of spring after failure: a – fracture surface; b – defects in the protective coating

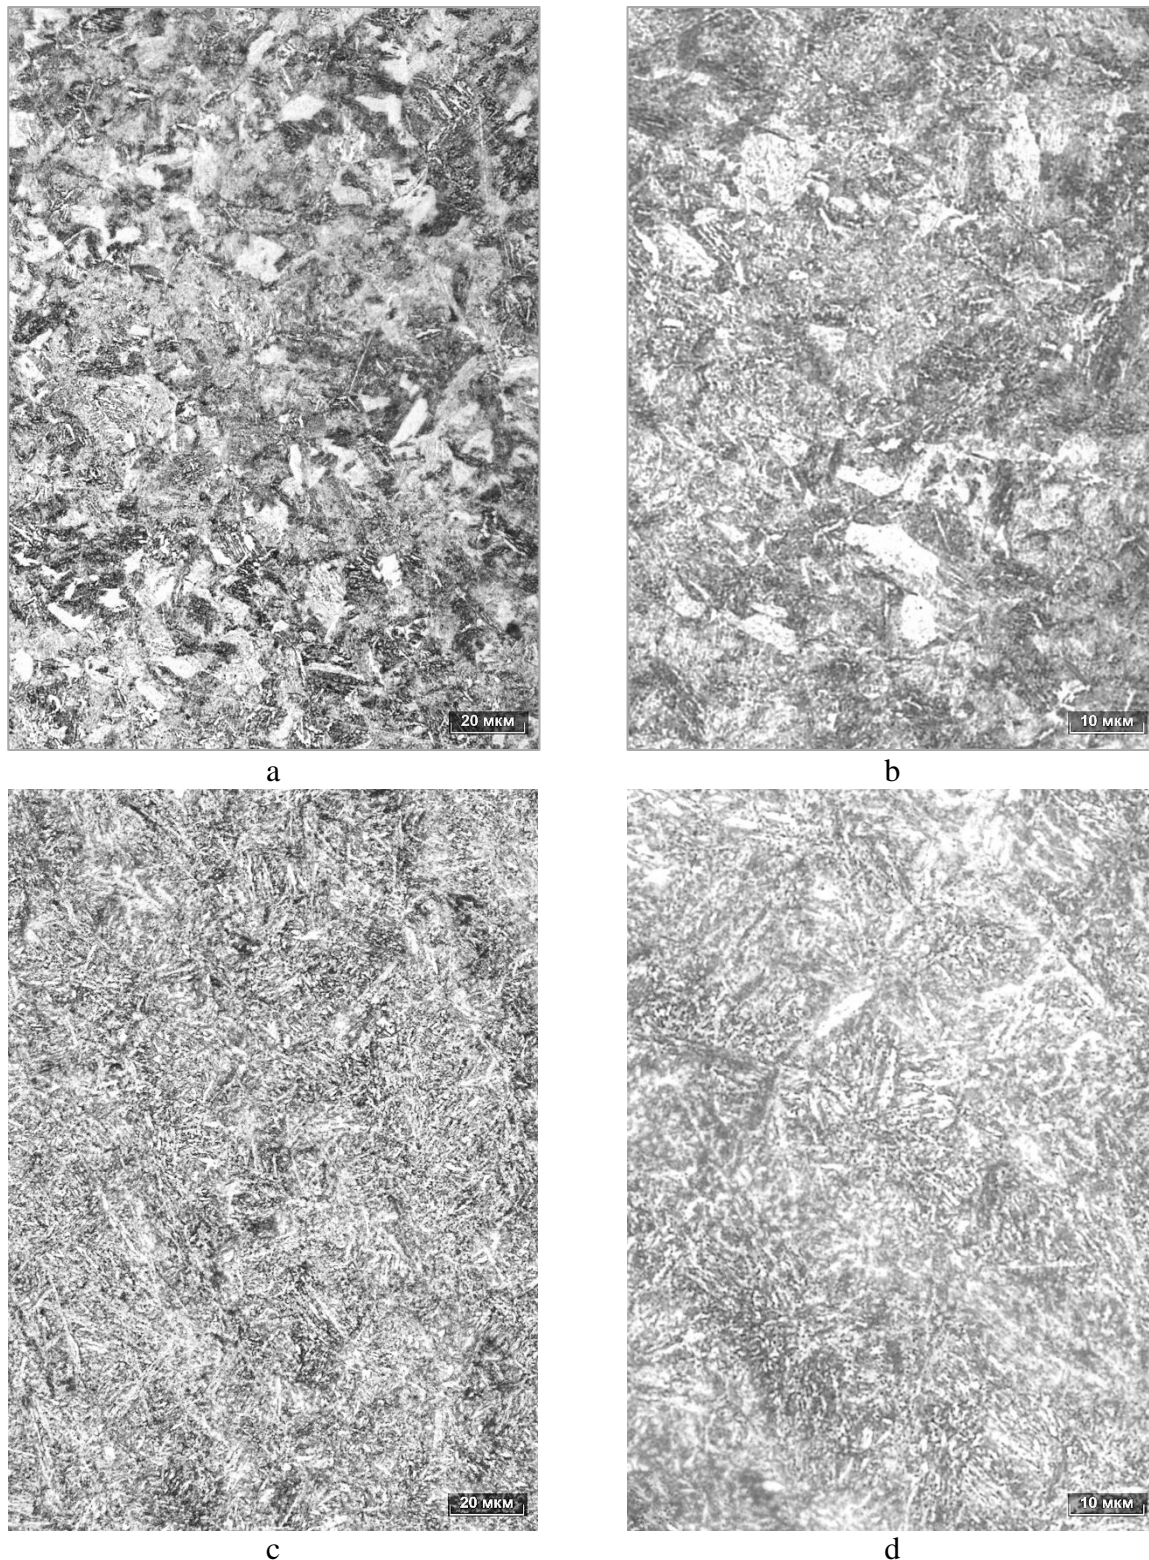
The microstructure of metal with the different fineness of special carbides (Table 3), which manifests itself in areas with different etching on the microsection (Fig. 2 a, b) and visible on SEM images at $\times 25000$ (Fig. 3 a), as well as the orientation along martensite

indicated quenching and medium tempering. The presence of bright polyhedral grains with carbide precipitates and low hardness (Table 2) indicated an insufficient heating temperature or a low cooling rate during quenching with the formation of regions of non-martensitic structures. After reductive heat treatment, the structure became more homogeneous (Fig. 2 c, d).

Fig. 2. The microstructure of the spring's metal after the operation (a, b) and after heat treatment (c, d): a, c – $\times 500$; b, d – $\times 1000$

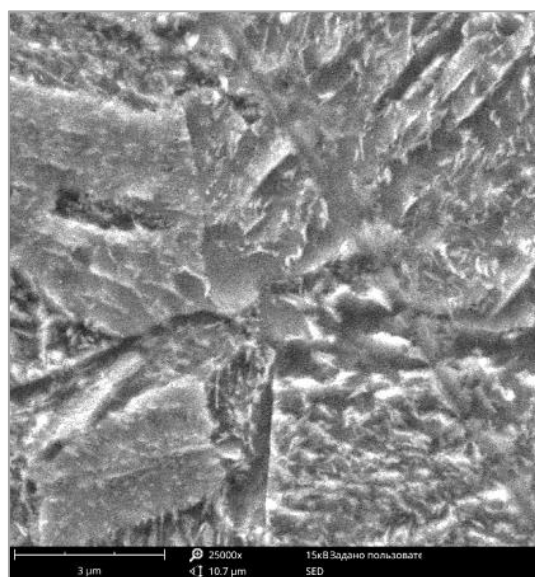
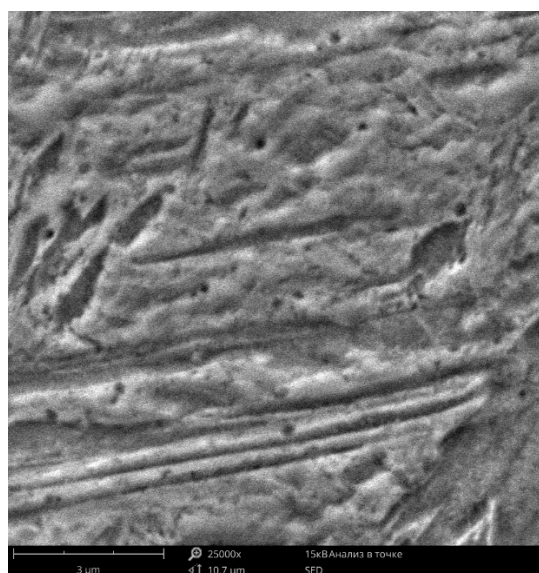
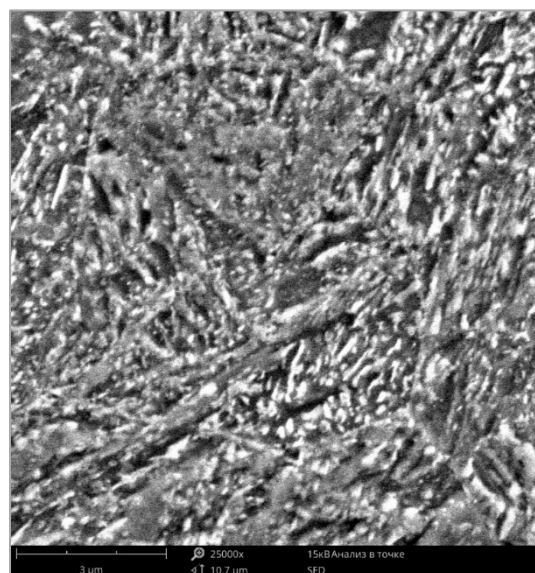
Fig. 3. Morphology of the carbide phase in the spring's metal, x25000, SEM image: a – after operation; b – after operation + quenching; c – after operation + quenching + tempering

A comparison of the morphology of the carbide phase before (Fig. 3 a) and after (Fig. 3 c) reductive heat treatment showed that the initial material had a lower distribution density of carbides with a predominance of lamellar precipitates. After the reduction heat treatment, the structure was dominated by round-shaped carbides with a size of 0.1 μm . It should be noted that the presence of carbides in the form of plates is not a defect and it's typical for spring steel after quenching and medium tempering, in contrast to coagulated carbides after high tempering, which reduces the elastic properties of springs.

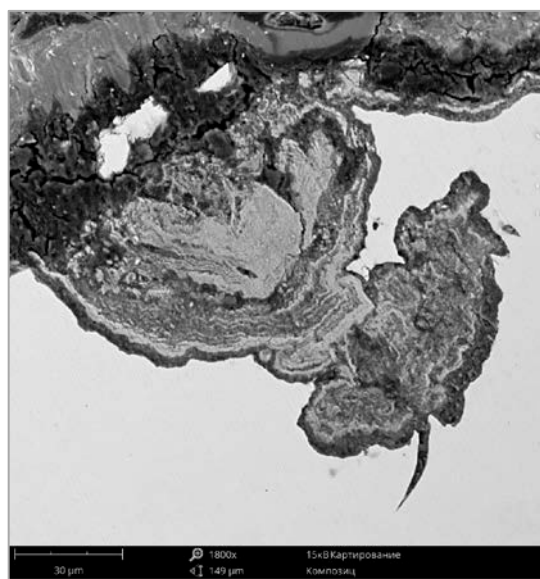
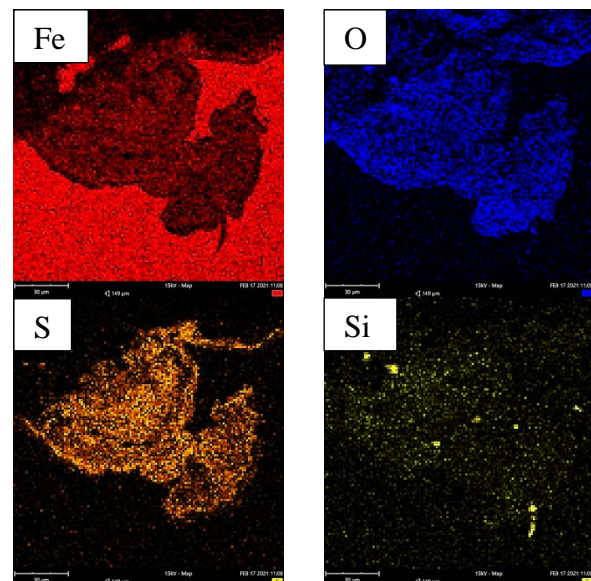
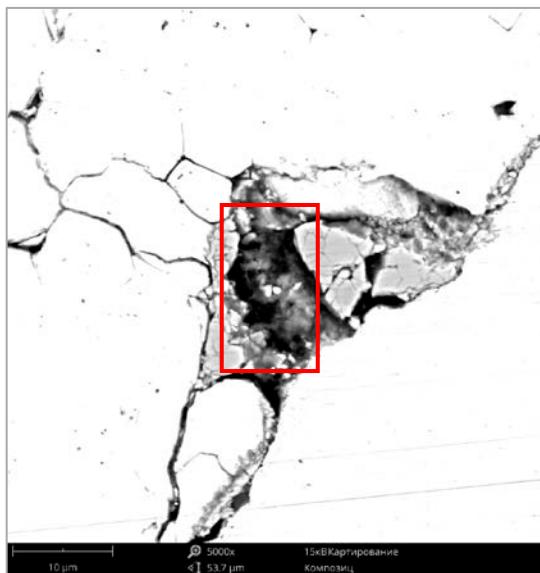
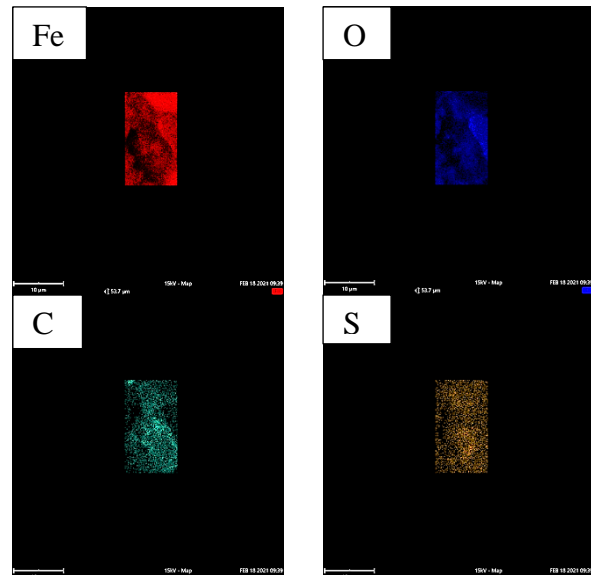
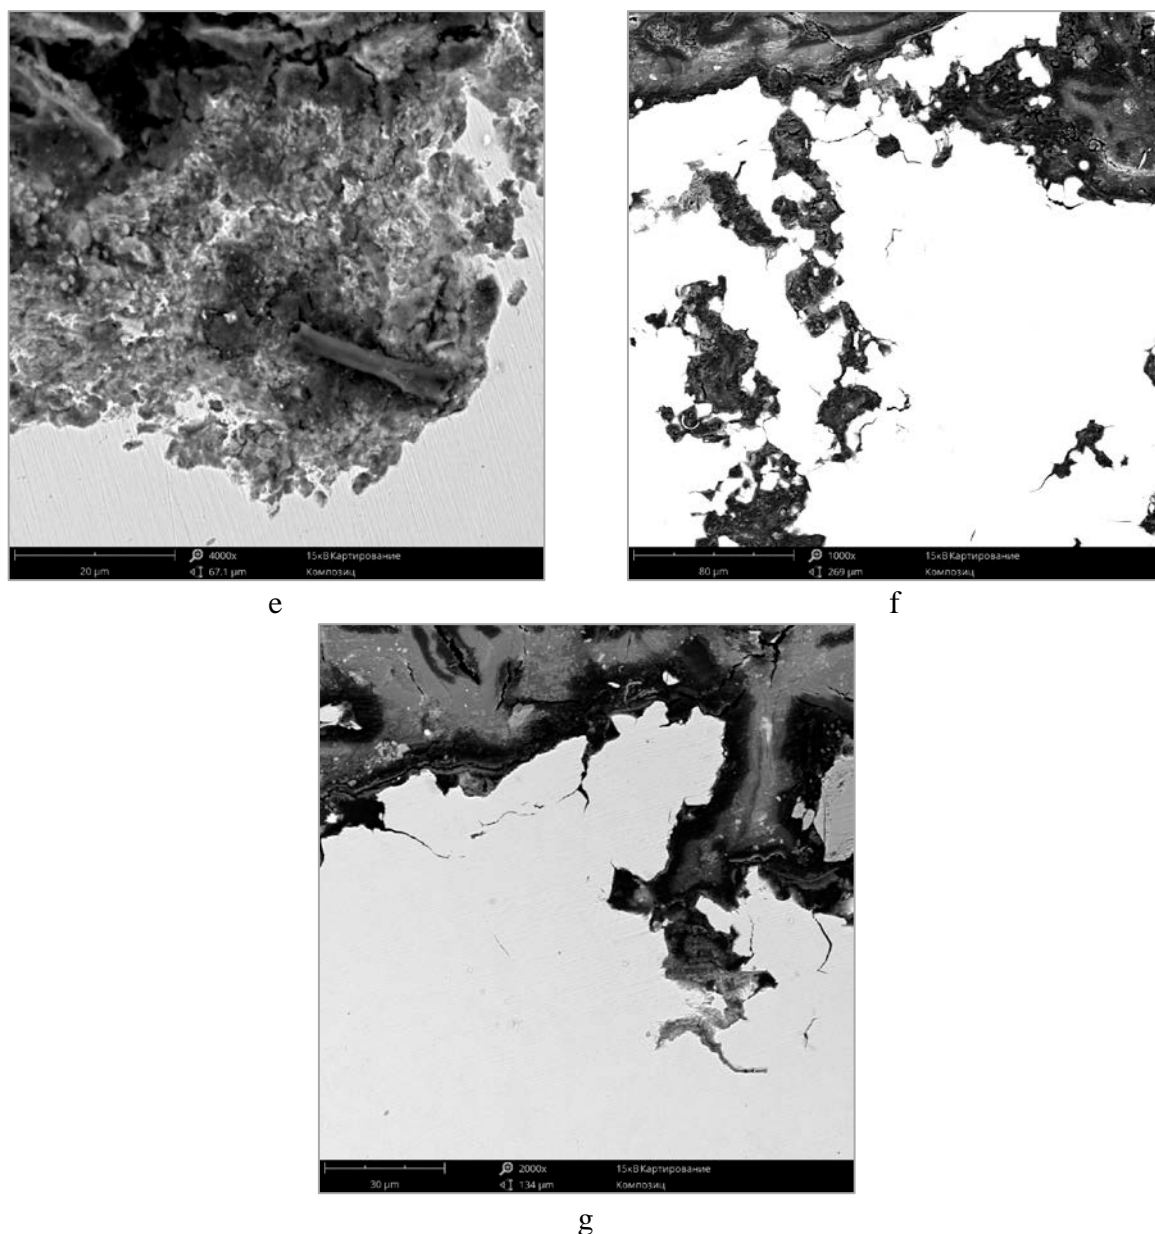
The study of the microstructure in the places of damage to the protective coating, revealed during visual and measurement control, showed the presence of multiple surface microdefects of the metal in the form of ulcerative damage and penetrating of corrosion products into the deep layers of metal (up to 1/3 of the rod section), as well as the destruction of metal near non-metallic inclusions and cracking mainly along the boundaries of primary austenite grains (Fig. 4). Analysis of the distribution of chemical elements in cavities and

cracks (Fig. 4 a-d) indicated a significant content of sulfur and oxygen, which indicated the occurrence of low-temperature hydrogen sulfide corrosion. The propagation of damage along with the structural elements and the morphology of cracks on microsections after etching with a 4% of HNO_3 solution are shown in Fig. 5, from which it can be seen that cracks propagate not only along the boundaries of primary austenite grains, where the largest precipitates of carbides are located but also along the interphase boundaries of oriented plates of carbides, pores in the matrix of the solid solution are also visible (Fig. 5 a, b). The smallest micropores up to $0.5\ \mu\text{m}$ in martensite, which were not eliminated by quenching during the reduction heat treatment (Fig. 3 b), were also found on microsections cut away from the surface of the spring, which may be due to the presence of hydrogen in the steel formed during low-temperature hydrogen sulfide corrosion.

Fig. 4. Defects in the spring's metal at the crack origin, not etched:

a, c – analyzed surface; b, d – element distribution map; e – destruction of metal at sulfide;
f, g – cracks and penetration of corrosion products into the deep layers of the metal

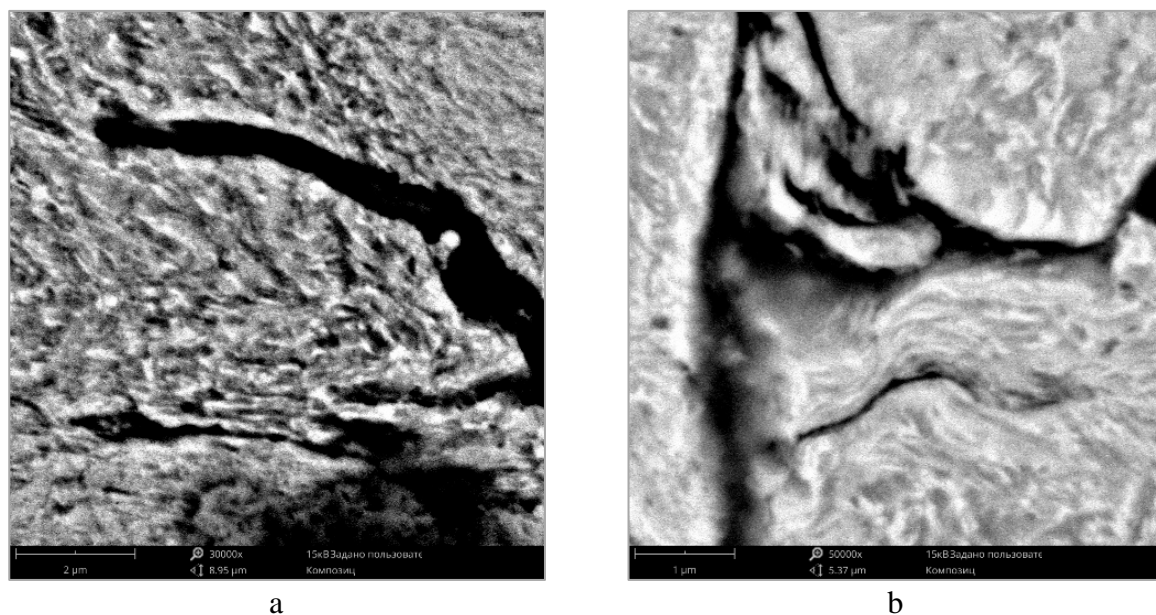
Figure 5 b shows that when the cracks form an almost closed loop, the metal is deformed under hydrogen pressure with the subsequent formation of cavities that reduce the resistance to operational loads and lead to failure.

Fig. 5. View of cracks after etching: a – $\times 30000$, b – $\times 50000$

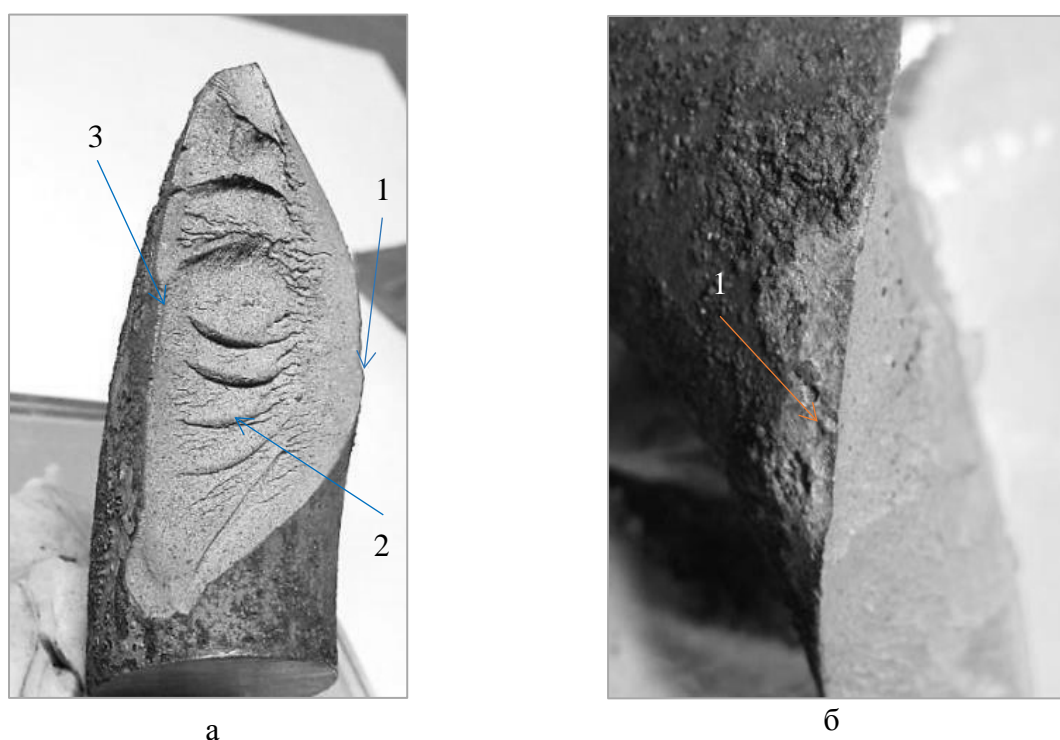
Fractographic research has established that the fracture is matte, dark gray in color. The fracture surface was oriented at an angle of 45° to the axis of the rod and perpendicular to the direction of action of the maximum tensile stresses during torsion, in the central part there was a concavity characteristic of quasi-brittle materials [20]. The macrogeometry of the fracture indicates the formation of fracture during the workloads. According to the macrostructure, the spring's fracture was characterized by the following successive zones: first – zone of crack origin with smooth relief, second – zone of failure crack propagation with ratchet marks, and third – fast fracture zone with less rough areas (Fig. 6). At the crack origin, determined by the convergence of ratchet marks, and located on the outer surface of

the spring between the small and large turn radius, there was a loss of protective coating, as well as ulcerative damage on the surface (Fig. 6).

Fig. 6. General view of the fracture of the spring:

1 – crack origin; 2 – failure crack propagation zone; 3 – fast fracture zone

5. On the basis of the studies carried out, a set of measures was recommended to improve the reliability and prevent the failure of safety valve springs operating in similar conditions: hardness measurement during receipt inspection, periodic visual measurement control, capillary, and magnetic particle inspection; monitoring the condition of the sealing surfaces; ensuring the quality of valve assembly after repair and alignment of the parts installation; the use of protective covers – bellows made of 08Cr18Ni10Ti steel or more

corrosion-resistant for similar springs, which do not allow penetration of aggressive environment to the surface of the spring.

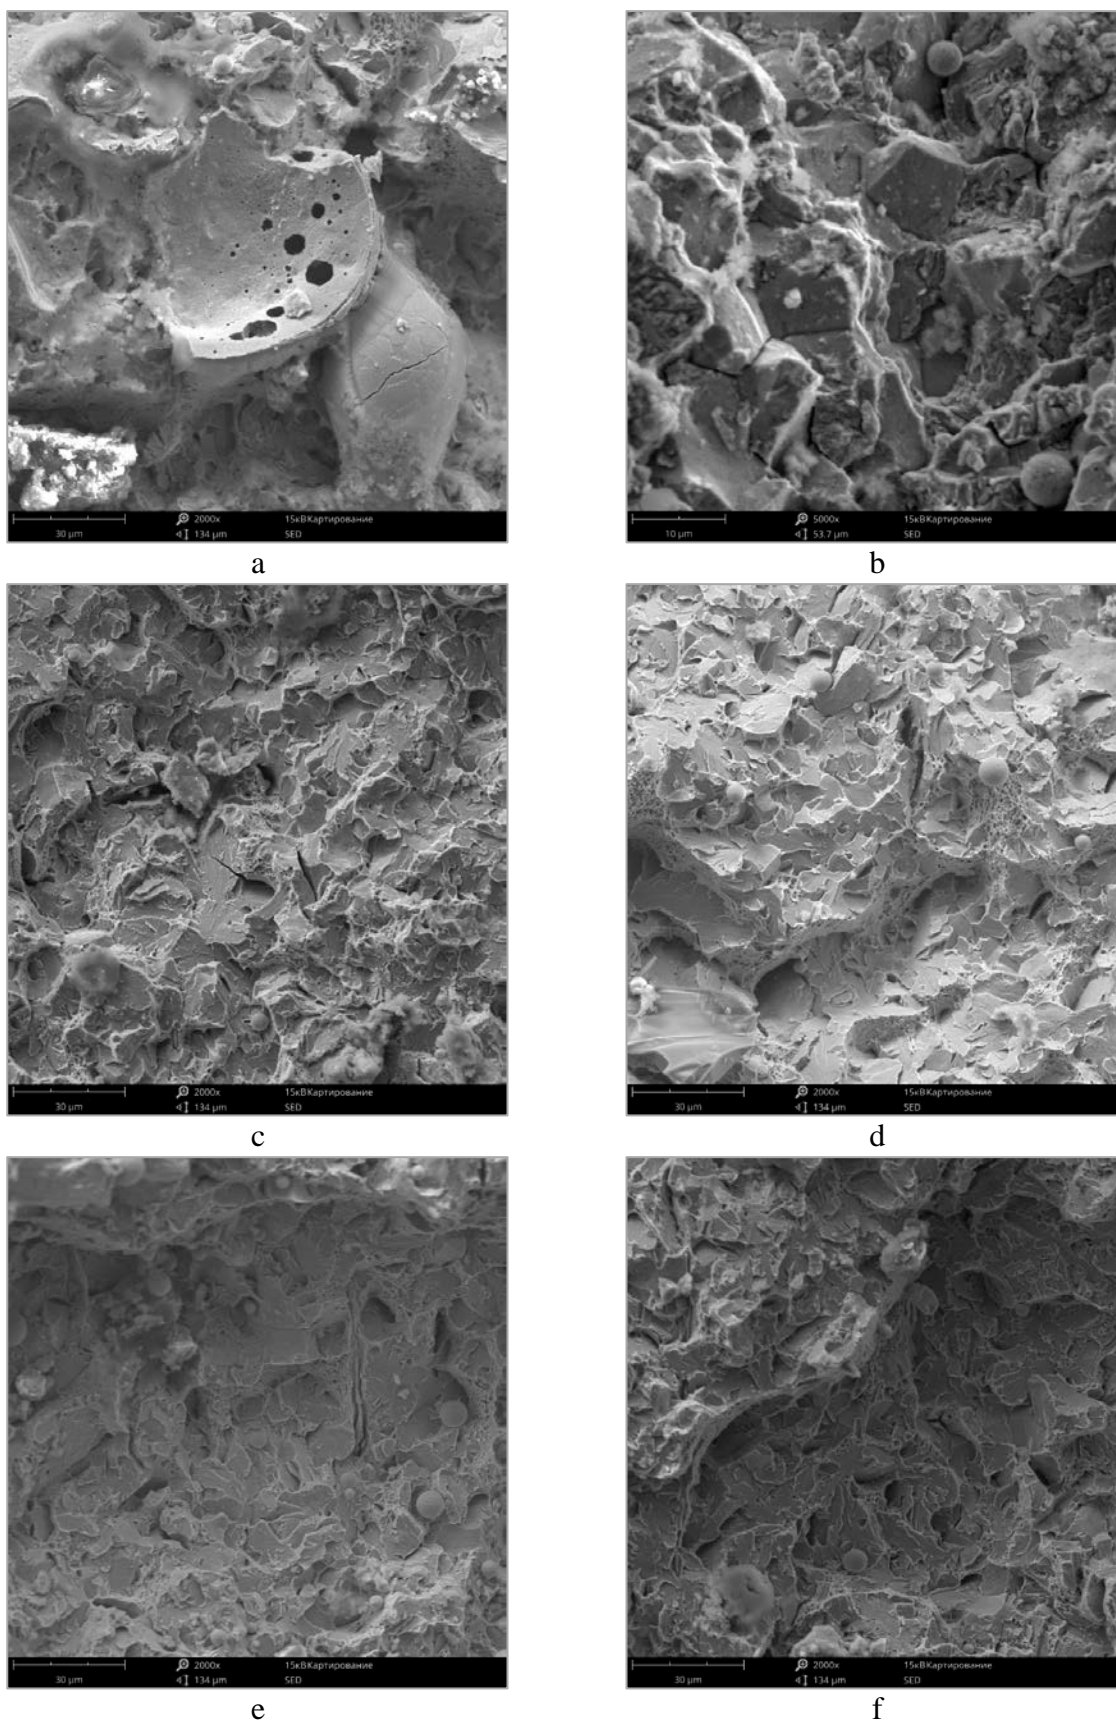
Fig. 7. Electron fractography of the spring's failure surface:
a, b – crack origin; c, d – failure crack propagation zone, zone of ratchet marks,
e, f – fast fracture zone

According to electron-fractographic studies, corrosion products were present in the crack origin coinciding with the place of damage to the coating, in the decarbonized surface layer there were open cavity-bubbles, bubbles with cracks (Fig. 7 a), non-metallic inclusions, intergrain facets, and cracks characteristic of corrosion damage were observed (Fig. 7 b). In the zone of failure crack propagation (Fig. 7 c, d) there were facets of cleavage and quasi cleavage, splitting by non-metallic inclusions, as well as pores typical for slow cracking under the influence of hydrogen [4,20-22]. The fracture surface in the ratchet marks zone was formed by facets of intercrystalline fracture with alternating quasi-cleavage and some areas of the dimple fracture. The fast fracture zone was characterized by facets of intergranular, transcrystalline fracture with areas of dimple fracture (Fig. 7 e, f). Thus, the propagation of the crack along the body of the spring proceeded by the mixed brittle-ductile mechanism.

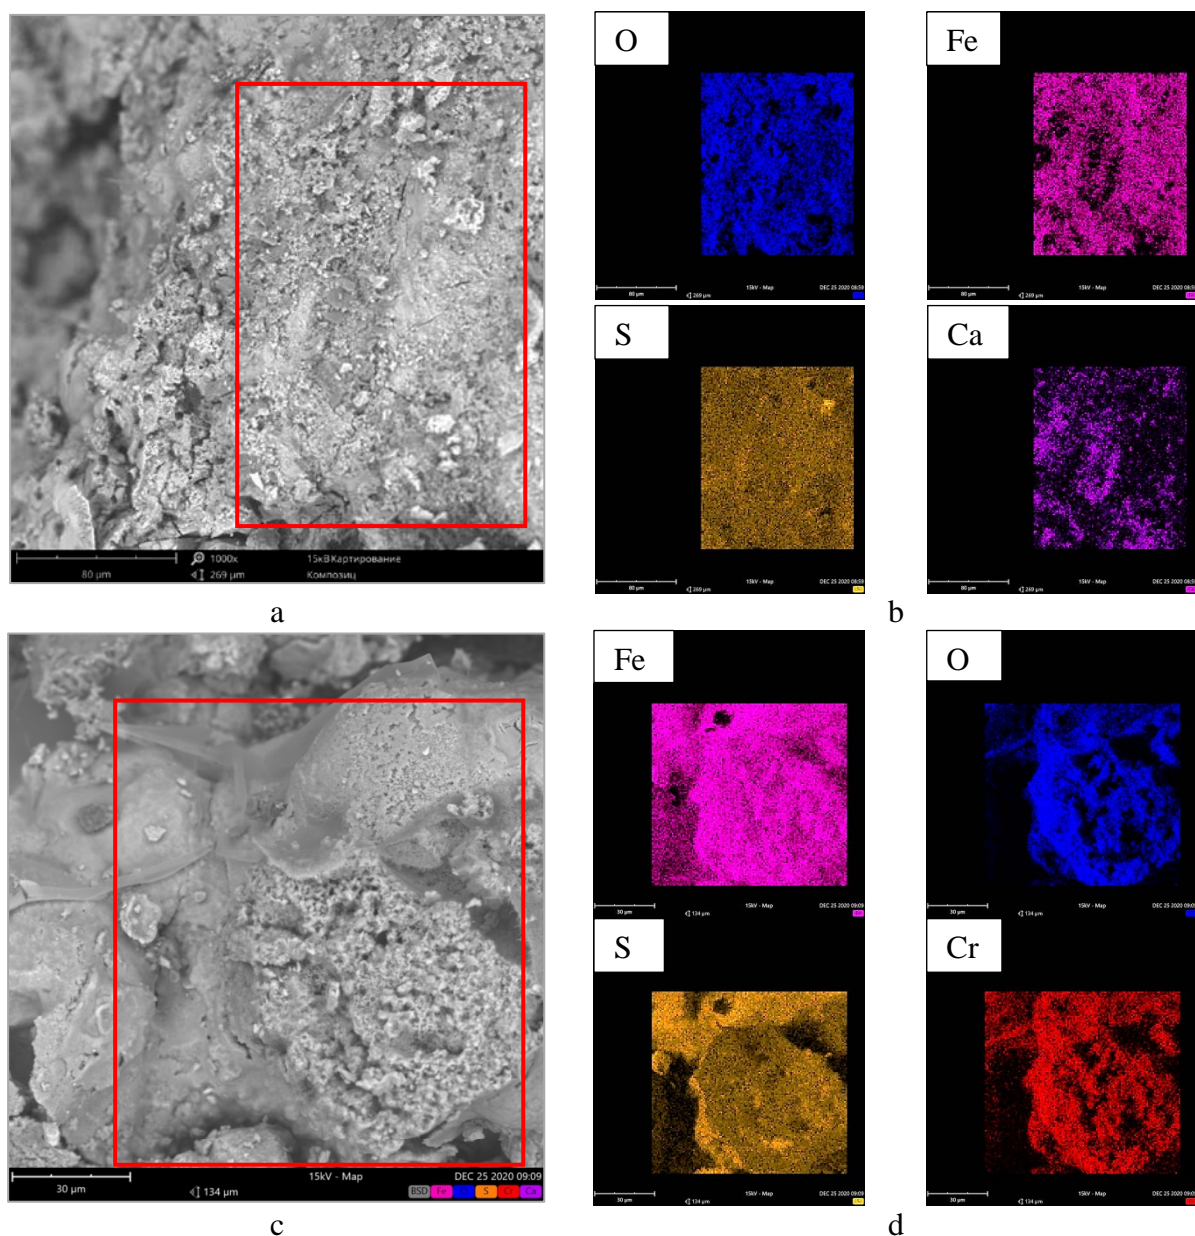
Fig. 8. Results of EDS of corrosion deposits from the metal surface:
a, c – analyzed surface; b, d – element distribution map

Using EDS corrosion deposits collected from the surface of the spring were investigated (Fig. 8), on the basis of the results of which it can be argued that the environment is highly

aggressive, the deposits mainly consist of iron sulphides FeS, oxide compounds of iron and sulfur, as well as particles containing a large number of chemical elements represented by pigments and fillers included in the composition of the protective coating.

Thus, the summation of the results of the study allowed us to conclude that the cause of the spring failure was low-temperature hydrogen sulfide corrosion. The most dangerous concomitant process of low-temperature hydrogen sulfide corrosion is the hydrogenation of steel, which is confirmed by the presence of blistering under the deposits. Such blistering is the result of the presence in the cavities of either hydrogen sulfide itself or hydrogen released during the reaction of hydrogen sulfide with iron. Hydrogen, diffusing deep into the steel, accumulates in places within crystal lattice defects and non-metallic inclusions, eventually forming internal pores and causing the development of microcracks, which ultimately lead to the creation of significant internal stresses and embrittlement of the metal. The presence of moisture in the working environment significantly accelerated low-temperature hydrogen sulfide corrosion and hydrogen saturation of steel, thereby accelerating its embrittlement.
