FAILURE ANALYSIS IN LIFETIME ESTIMATION OF RAILS

Abstract. An attempt is made to find the relationship between the mechanical properties of the material in microvolumes and the properties of the material under load. A fractographic analysis of the surface of a fatigue fracture of a railway rail with an internal transverse crack is presented. The relationship of fractographic features with the structure of the material is discussed.

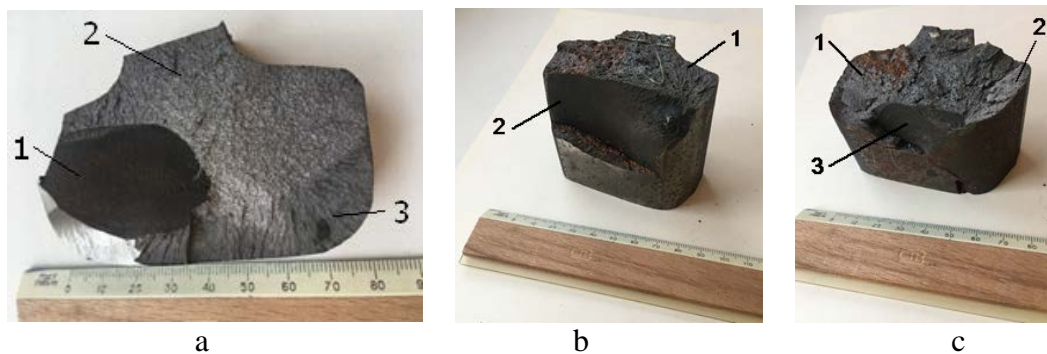
Fig. 1. View of fracture rail fracture surface: a – *rail_a*, b – *rail_b*, c – *rail_c*

As can be seen from Fig. 1, three zones stand out on the fracture surface *rail_a*. The fractures of the three zones (*rail_a*) are shown in Fig. 2, and the proportion of the viscous component S (shear area in %) on the fracture surface of these three fracture zones is presented in Table 1.

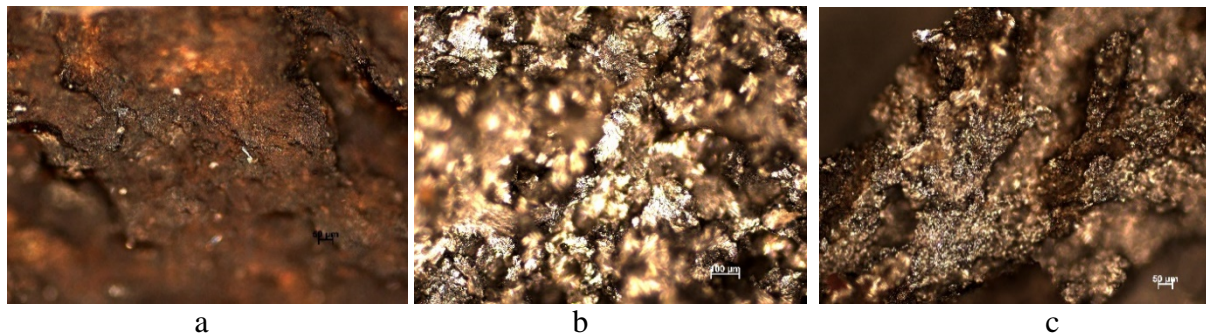
Fig. 2. Fracture zones (*rail_a*): a – 1, b – 2, c – 3

As can be seen from the data presented, the most brittle failure is observed in the first zone (*rail_a*) – this is the last stage of rail fracture, it begins in the third zone, propagates in the second, and ends in the first, where, in addition to the applied loads, the temperature is also observed similar data in [11]. Samples *rail_b* and *rail_c* with longitudinal cracks have more brittle fracture than specimen *rail_a* with only transverse cracks (Table 1).

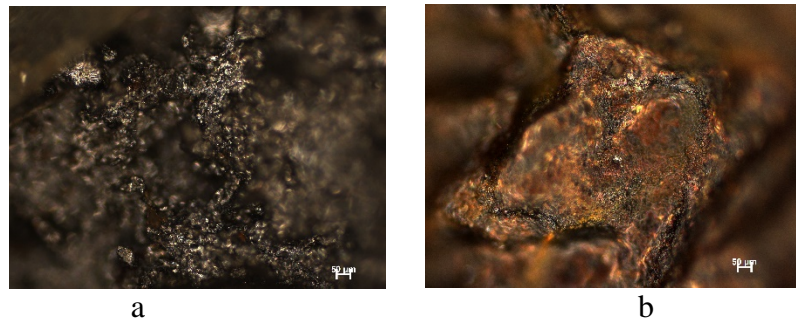
Two fracture zones of *rail_b* sample are presented in Fig. 3. Three fracture zone in the sample *rail_c* are presented in Fig. 4. The proportion of the viscous component on the fracture surface of fracture zones of these specimens is presented in Table 1.

Fig. 3. Fracture zones (*rail_b*): a – 1-transverse, b – 2-longitudinal

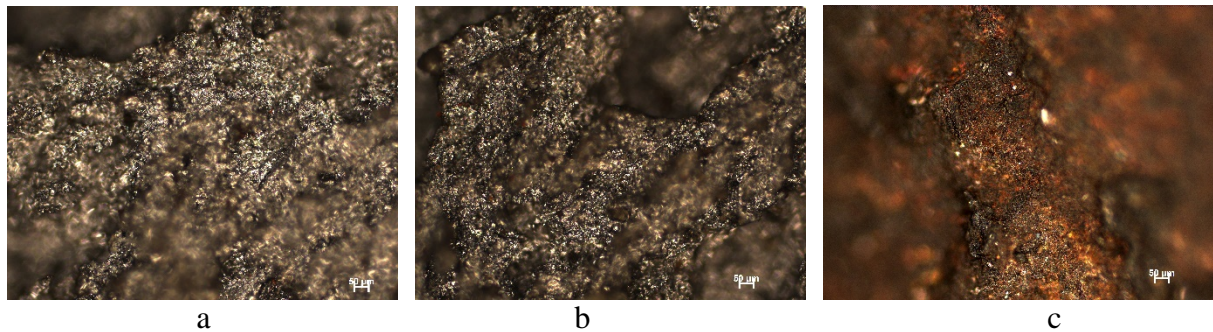
Fig. 4. Fracture zones (*rail_c*): a – 1-transverse, b – 2-transverse, c – 3-longitudinal

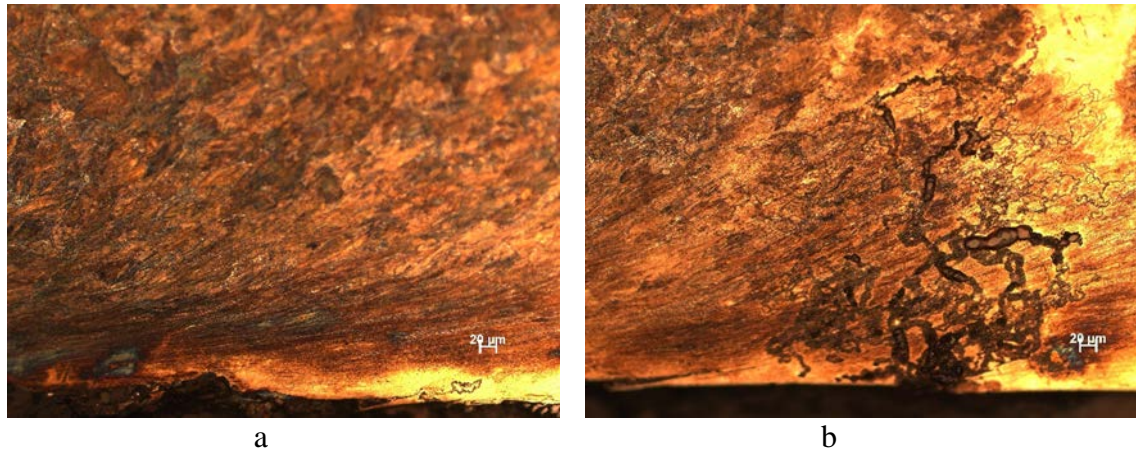
Area 1. The final stage of fracture. In this region near the fracture surface, the structure has a flow pattern, where all structural components are mixed (Fig. 5a), and there is also a branched network of microcracks (Fig. 5b).

Fig. 5. Microstructure at the fracture surface of region 1 ($\times 200$)

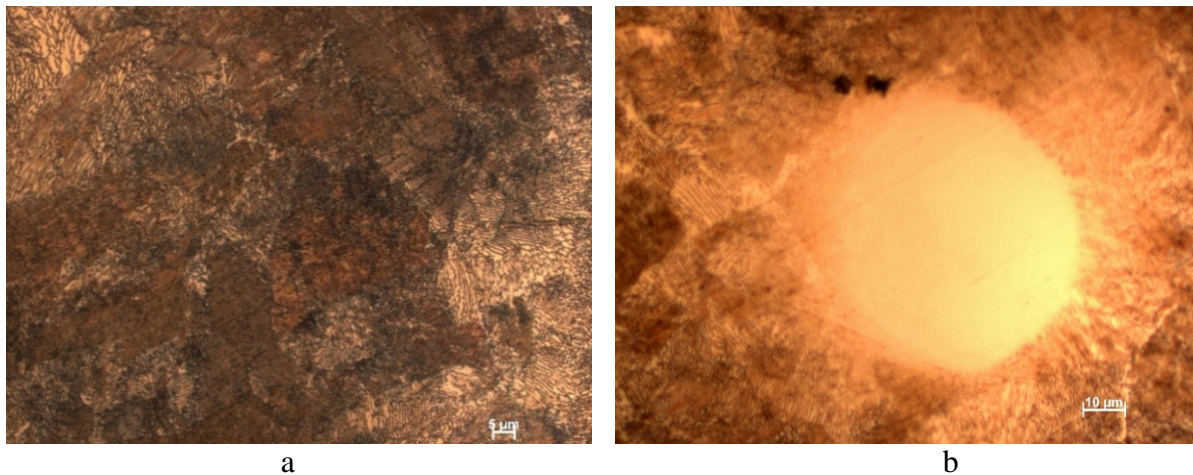
In the center of this region (Fig. 6a), a plate-perlite structure typical for this steel is observed, as well as regions of dynamic recrystallization (Fig. 6b), which are often observed under dynamic loading similar to those which were revealed Atroshenko [12].

Fig. 6. Microstructure in the center of the region 1 ($\times 1000$)

As a result of heating and rapid cooling in these areas of dynamic recrystallization, a microcrystalline structure is observed up to the nanostructure. In some areas of these regions, grain has already grown to 4 μm . As a result of strong heating, annealing occurred in some areas, and lamellar cementite turned into globular, and sometimes it dissolves similarly data of work [13]. If in the third region with which crack initiation and fracture began, the size of the grain and structural components – cementite and ferrite – was smaller (Table 3) then in the second region, these values increased, and in the first area, they were maximum.

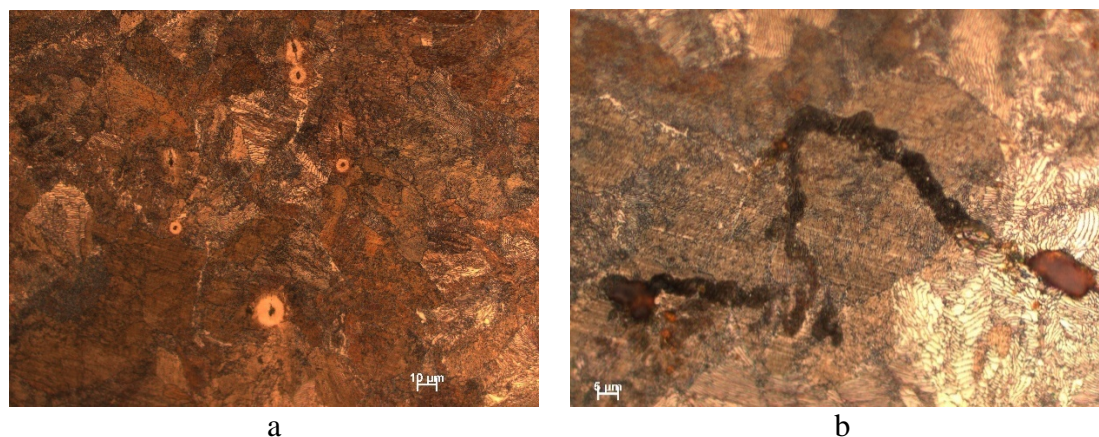
Area 2. The intermediate stage of fracture. The onset of an internal longitudinal crack defect is microcracks from accumulations of nonmetallic inclusions elongated during rolling in the form of path lines, which are visible in the microstructure photo (Fig. 7a).

Fig. 7. The origin of microcracks from lines along the rolling (a $\times 500$) and microcracks (b $\times 1000$)

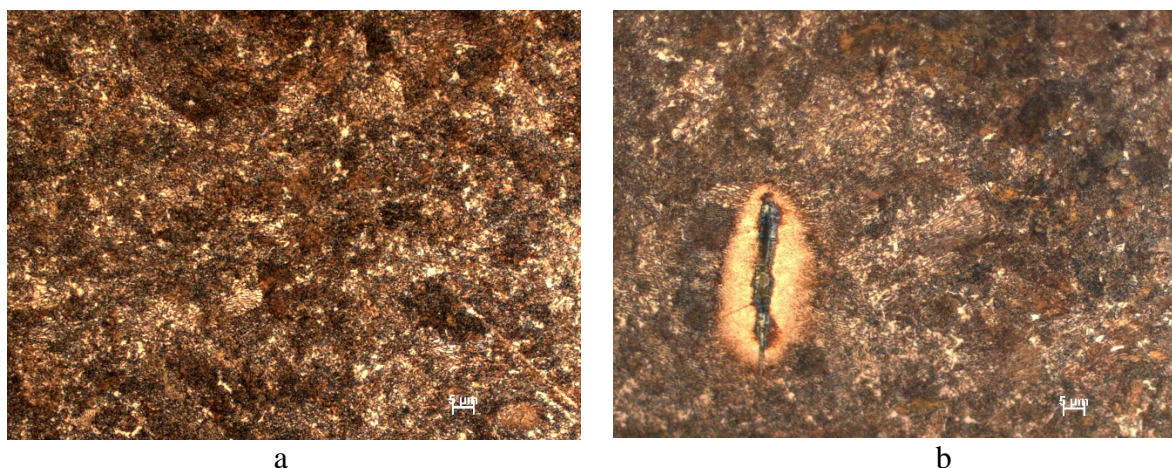
Area 3. The initial stage of fracture. The structure of the initial fracture region is lamellar perlite with a rather fine grain (Table 3) (Fig. 8), in some places of which there are emerging microcracks along the lines from rolling (Fig. 8b).

Fig. 8. Steel structure in the central fracture region ($\times 1000$)
