INVESTIGATING FAILURE OF AUTOMOTIVE COMPONENTS MADE OF POLYDICYCLOPENTADIENE

Citation: Romanova N.V., Shafigullin L.N., Erofeev V.T. Investigating failure of automotive components made of polydicyclopentadiene // Materials Physics and Mechanics. 2021, V. 47. N. 6. P. 864-871. DOI: 10.18149/MPM.4762021_6.

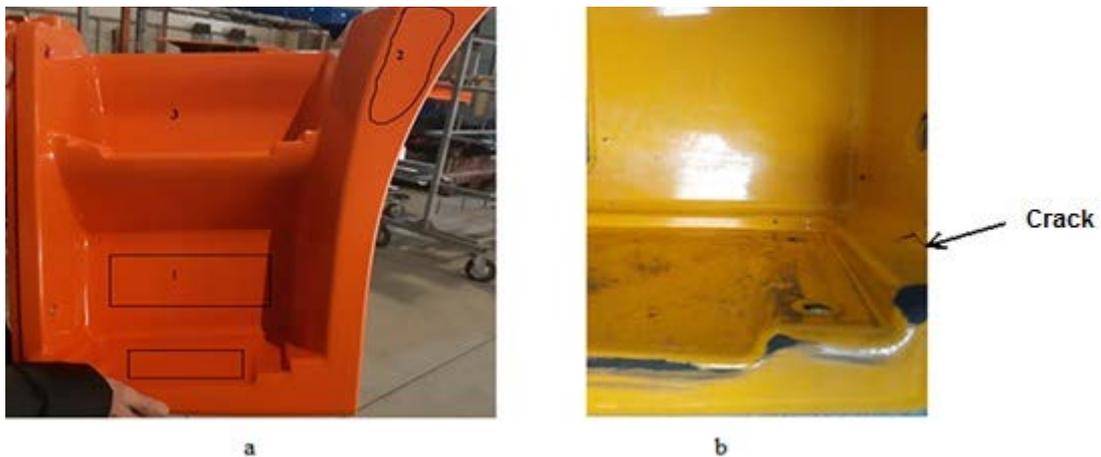
The most common failure mode of KAMAZ vehicle side step frame is the formation of a crack in the corners of the part due to continuous loading (Fig. 2) because corners are stress concentrations. The tensile stress is highest at such locations and exceeds the tensile stress when there are no corners. The inner corners in products should have a significant rounding radius [21].

Fig. 2. The sample of the side step frame without any defects (a) and with a defect (b)

The analysis of the crack showed the presence of brittle failure in the corner of the part. It is known [22] that cross-linked thermosetting plastics fail mainly due to mechanical fatigue (a polymer fails if the temperature increases insignificantly during cyclic loading), which depends on various factors such as stress level and geometry of a part. Breaking of a molecular chain and sliding of molecules can weaken the material and initiate cracks.

The study of the cross-section of the crack showed that the product had minimal thickness in the failure area. The average product thickness in the failure area was 2.8 mm. According to Telene documentation [23], the minimum thickness of an end product should be not less than 3 mm to achieve the maximum degree of polymerization and to make a product with the best properties. A decrease in the product thickness can lead to the effects of thermal oxidation.

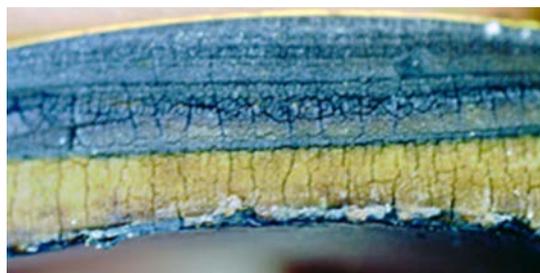
Figure 3 shows the cross-section of the crack which has visible traces of material degradation and irregular areas, which is indicative of a catastrophic failure of the material. The common cause of this product failure is excessively fast cooling or overheating of a

mold, which results in fast polymerization or short molding. As a result, the strength properties decrease due to a stress concentration in the areas of weakness.

Fig. 3. Photomicrograph of the crack in the defective part

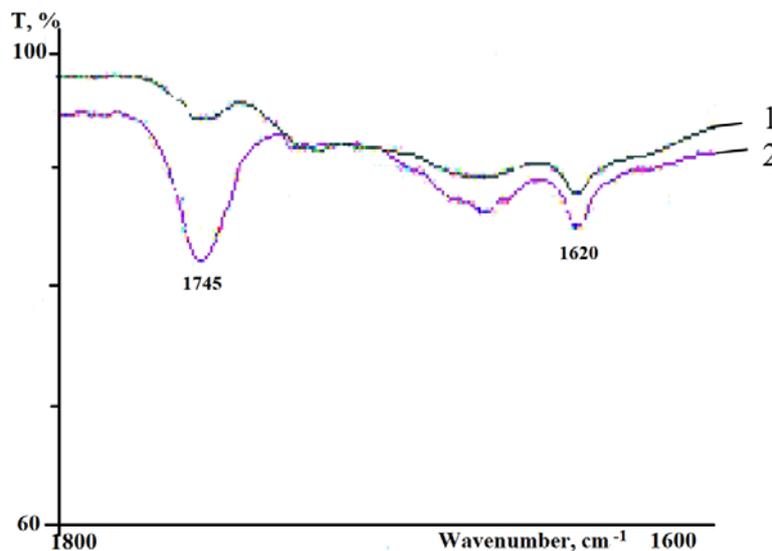
Fig. 4. IR spectra of samples N (1) and F (2)

The study of the IR spectra of PDCPD samples showed (Fig. 4) that sample F (unlike sample N) featured a more intensive peak at around 1745 cm^{-1} , which corresponded to the vibrations of carbonyl groups -C=O . It indicates that oxidized structures were formed. The probability of formation of these structures can be a result of the thermal oxidation of the end product due to violation of the production process, operation at increased temperatures, and UV exposure, as well as low-quality raw materials.

It is likely that oxidized raw materials were used during the polymerization process. It is known [26] that DCPD monomer oxidizes during the storage and carbonyl groups are formed, probably aldehyde and ketone groups, which corresponds to the vibrations at around 1700 cm^{-1} in the IR spectrum. The presence of active double bonds in DCPD monomer encourages the addition of oxygen when subjected to atmospheric oxygen, UV light, and heat. It leads to the formation of oxygen-containing impurities which can suppress or inhibit polymerization.

Therefore, the presence of reactive double bonds in a monomer and polymer encourages the active behavior of thermal-oxidative degradation processes, as evidenced by the IR spectra of the failed PDCPD sample. Thus, the presence of an intensive peak at around 1745 cm^{-1} , which corresponds to the vibrations of carbonyl groups -C=O , is evidence of the formation of oxidized structures.
