DETECTION OF A NEW METHOD FOR CORROSION DEFECTS IN TURBINE IMPELLER BLADES BY NON-DESTRUCTIVE TESTING

Esmail Mirmahdi*, Davood Afshari

Abstract. The turbine impeller is a separate component that forms an important part of a turbine. These blades are used to extract energy and play a very important and key role in a turbine. The evaluation of the blades can be evaluated by non-destructive tests depending on their shape and dimensions, and the ability to detect the amount of corrosion in these blades is the main discussion of this article, which was accurately measured by ultrasonic testing method. This defect Due to its high performance in turbines in the oil and water industry, it will be an interesting challenge to test it for non-destructive testing. Corrosion diameter is personalized by ultrasound, which is a new method in this test. An experimental test was performed for turbines with defective blades selected from 100 blades with corrosion defects. 20 blades with more corrosion were selected. Defect signal size and defect size are simulated by Comsol software. According to various tests on the size of the corrosion defect diameter, the approximate life and operating hours of

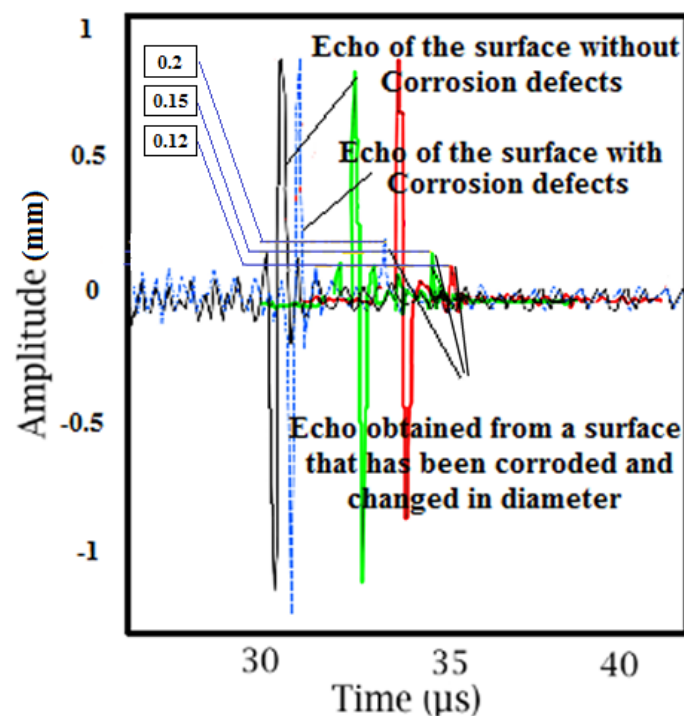
Fig. 1. Return echo of the defect (without/with corrosion defects with the exact size of the corrosion)

In the experimental test, the ultrasonic wave test was used to measure corrosion defects. The selected probe is a 5 MHz probe in which the impeller is tested by immersion. The test was then performed on a blade that was corroded and showed a certain amount of defect. In this case, we observed the recursive echo of the defect, which fully represents the size and amount of the diameter. Figure 1 shows the amount and size of corrosion diameter in several selected turbine blades by defective and non-defective return echo.

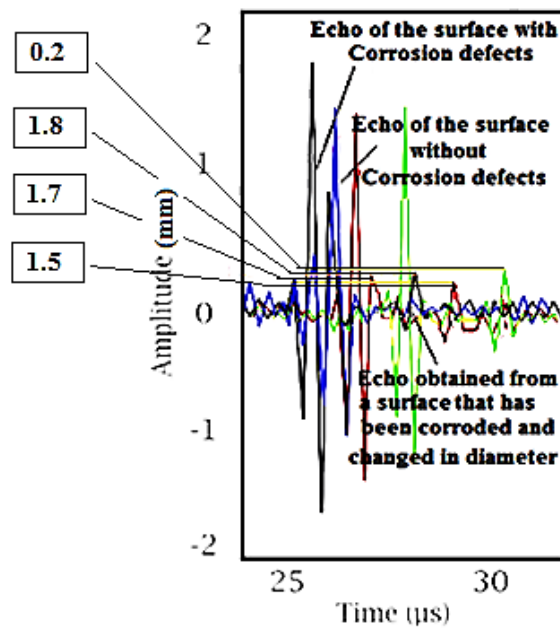
Fig. 5. Simulated corrosion defect echo (with and without corrosion)

The excitation signal by applying the Gaussian window is taken by adopting 2.5 cycles for the sinusoidal signal, it was shown in Fig. 4 [23]. This simulation was performed to determine the size of the corrosion and Fig. 5 was indicate the simulation results are obtained with and without defects. Different results of defect signal echoes have been obtained for different sizes of corrosion defects. This size of the return echo of the defect indicates the exact size of the corrosion defect.
