Tool wear and surface roughness analysis in hard turning of AISI 4340 steel with coated carbide inserts

The performance of CVD-coated carbide inserts (TiCN/Al₂O₃) in hard turning AISI 4340 steel at cutting speeds of 60, 95, 180, and 250 m/min, under both dry and wet conditions are investigated. The goals were to evaluate tool wear, surface roughness, and wear mechanisms over different machining conditions. Surface roughness Ra value was noticed, and it dropped to Ra = 0.30 μm at 180 m/min but increased at 250 m/min due to vibration, edge instability, and wear. Flank wear rose with cutting speed: 186 μm at 60 m/min, 265 μm at 180 m/min, 542 μm at 250 m/min (dry), and 692 μm (wet), exceeding ISO tool life (VB = 300 μm) due to edge breakage, flaking, and adhesion. The examination of the tool surface by SEM and EDS revealed abrasion and slight coating delamination at low speeds, adhesion and oxidation at intermediate speeds, and catastrophic tool failure at high speeds.

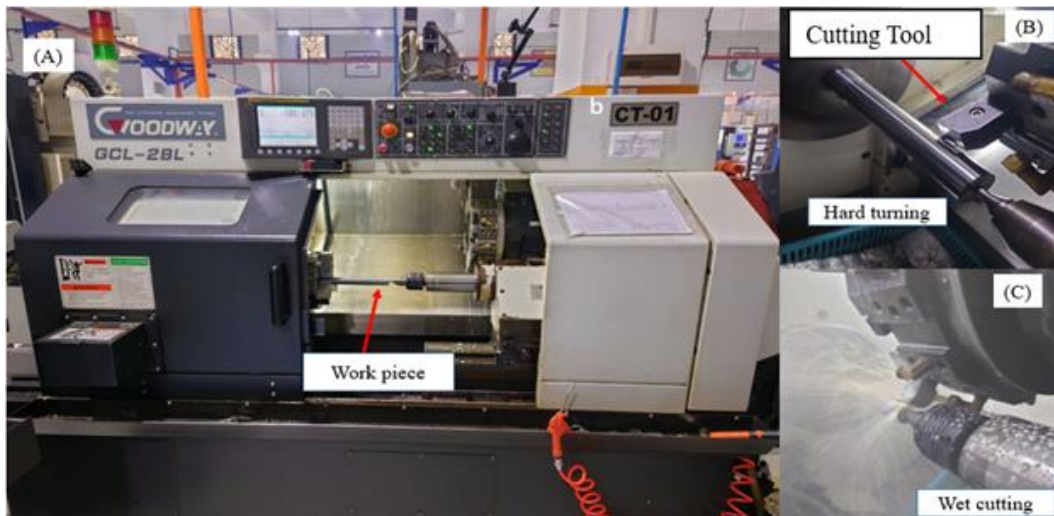
Fig. 2. Experimental setup showing (a) CNC lathe, (b) tool and workpiece, hard turning, (c) wet cutting with coolant

Turning experiments were conducted utilizing a Goodway CGL-2 CNC lathe equipped with a FANUC Oi-TF control system shown in Fig. 2(a). The tool-workpiece configuration is depicted in Fig. 2(b), illustrating the hard turning of the heat-treated AISI 4340 steel. For wet machining trials at 250 m/min, a commercial mineral based cutting oil (Arab Lube, diluted at 1:20 with water) was applied as a conventional flood coolant, and was used exclusively at a cutting speed of 250 m/min as depicted in Fig. 2(c) The coolant was directed at the tool–chip interface through an external nozzle to evaluate its effectiveness at high-speed cutting conditions. Cutting experiments were carried out at four cutting speeds of 60, 95, 180, and 250 m/min, while the feed rate and depth of cut were kept constant throughout the study at 0.1 mm/rev and 0.5 mm, respectively. This

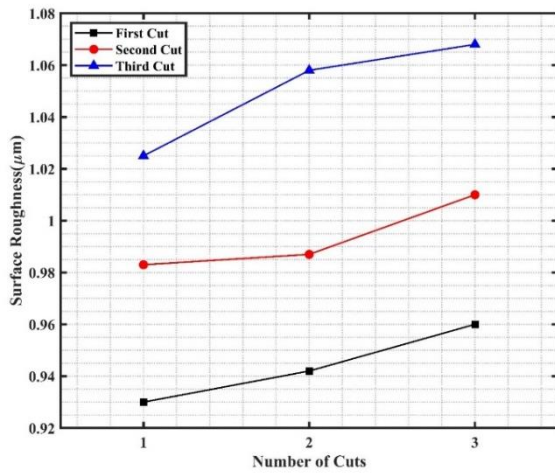
Fig. 8. Surface roughness at $V = 60$ m/min

The surface roughness (R_a) 0.931–1.069 μm with the cutting speed V of 60 m/min that corresponded to the three subsequent cuts (Fig. 8) was also characterized by a relatively high roughness. From 95 m/min, increasing the cutting velocity the surface roughness decreased to 0.657–0.877 μm (Fig. 9). At 180 m/min, even better results were achieved, showing R_a values of 0.303–0.612 μm (Fig. 10). Such a gradual decrease in R_a at higher speeds is considered to result from the shorter tool workpiece contact time and thermal

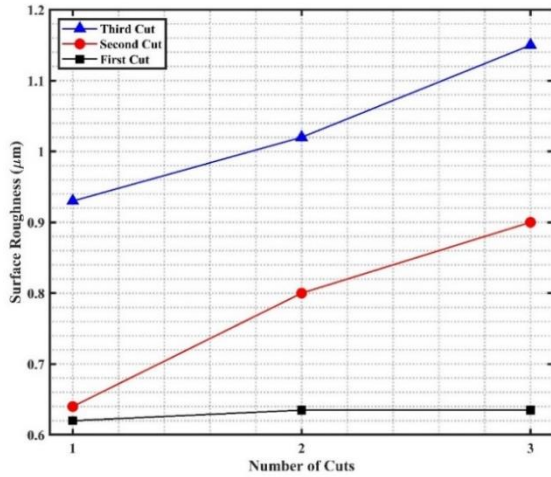
Fig. 11. Surface roughness at V = 250 m/min

softening of the workpiece material that enables smoother cutting. Similar trends have been reported in previous studies [28]. Surface roughness R_a was increased at 250 m/min (the maximum cutting speed) than at 180 m/min as depicted in Fig. 11. At higher cutting speeds, the cutting tool may suffer from extreme edge damage, such as flaking, notching or even catastrophic wear, which results in a blunt edge [18]. This can result in uneven cuts and differences in the texture of the surface. In addition, chatter and vibrations introduce oscillations at the tool edge, which cause the formation of an irregular surface pattern, and consequently an increase in the roughness [29].

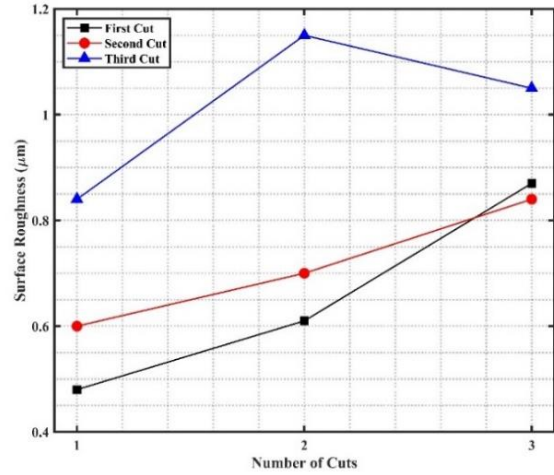
Fig. 12. Surface roughness at V = 50 m/min (wet)

Furthermore, for the highest speed of 250 m/min, surface roughness values became slightly better when wet cutting was performed (from 0.490 to 1.069 μm) than those for dry cutting, as presented in Fig. 12. It is noted that, despite the coolant application, R_a increased on the third cut, and the trend was different in comparison with the first cut at this speed. The uneven roughness pattern at high speeds, even during wet machining might be caused by vibration, instability, or sudden tool breakage and notching in the tool's cutting edge [30]. The general behavior is highlighted in Fig. 13, which collects R_a variation at all cutting speeds and conditions. The results show a U-shape, i.e., roughness decreases with increasing speed up to 180 m/min where the lowest surface roughness ($R_a \approx 0.30\text{--}0.61 \mu\text{m}$) was achieved, and increases again at 250 m/min. In wet cutting at

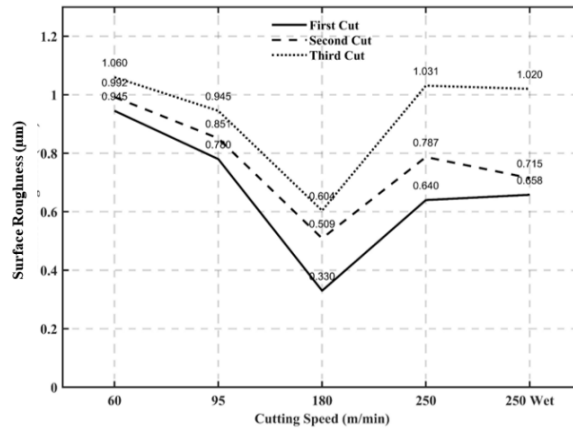
Fig. 13. Variation of surface roughness (R_a) with cutting speed for different numbers of cuts

250 m/min, R_a values became better than for dry cutting but increased with respect to moderate cutting speeds (95–180 m/min). These findings confirm that moderate to high cutting speeds (95–180 m/min) provide the optimum balance between surface finish and machining stability, whereas excessively high speeds lead to deterioration despite the use of coolant, due to high cutting temperature and excessive tool wear [15].

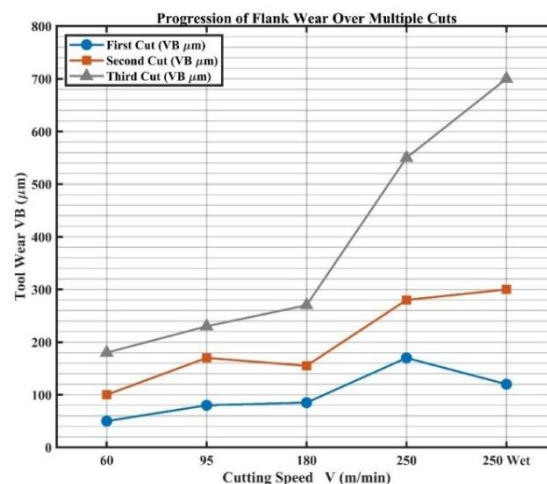
Fig. 14. Flank wear progression (μm) across first, second, and third cuts at different cutting speeds, including wet conditions

Figure 14 depicts the flank wear (VB) evolution through several cuts at different cutting speeds. The wear measured from 186 μm at 60 m/min to 229 μm at 95 m/min, and 265 μm at 180 m/min. At 250 m/min, wear sharply increased to 542 μm under dry conditions, exceeding the ISO 3685 tool life standard ($V_b = 300 \mu\text{m}$). Under wet conditions at 250 m/min, wear reached 692 μm as depicted in Table 3 after final cut. Elevated temperatures in hard turning led to coolant evaporation, which failed to cool the tool, causing thermal softening and reduced wear resistance [31]. These results indicate that tool wear remains moderate up to 180 m/min but becomes significant beyond that, with catastrophic wear at 250 m/min.

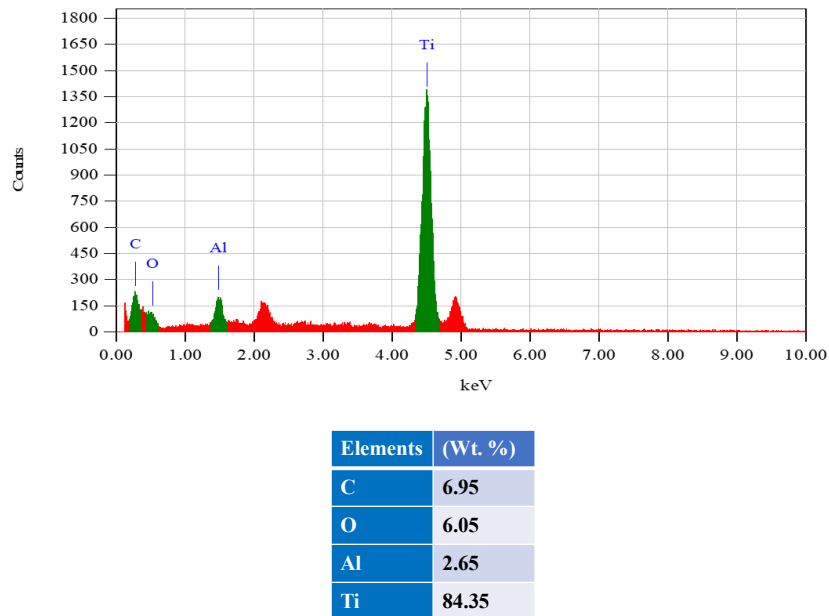
Fig. 17. EDS analysis of the fresh CVD-coated carbide insert before cutting

The EDS analysis of the fresh CVD-coated carbide insert, shown in Fig. 17 reveals the presence of carbon (C), oxygen (O), aluminum (Al), and titanium (Ti) supporting the multi-layer coating structure ($\text{TiCN}/\text{Al}_2\text{O}_3$) on the tool. Notably no tungsten (W) was noticed on the fresh tool surface, as the underlying substrate is fully covered by the CVD coating. This baseline composition provides a clear reference for interpreting element redistribution during machining.

The substantial tungsten content observed in the EDS analyses of worn tool surfaces (10–59 wt. % in Figs. 18–22) is attributed to the substrate material (W). As seen in the EDS analysis of the fresh insert (Fig. 17), no tungsten is detected on the unused tool due

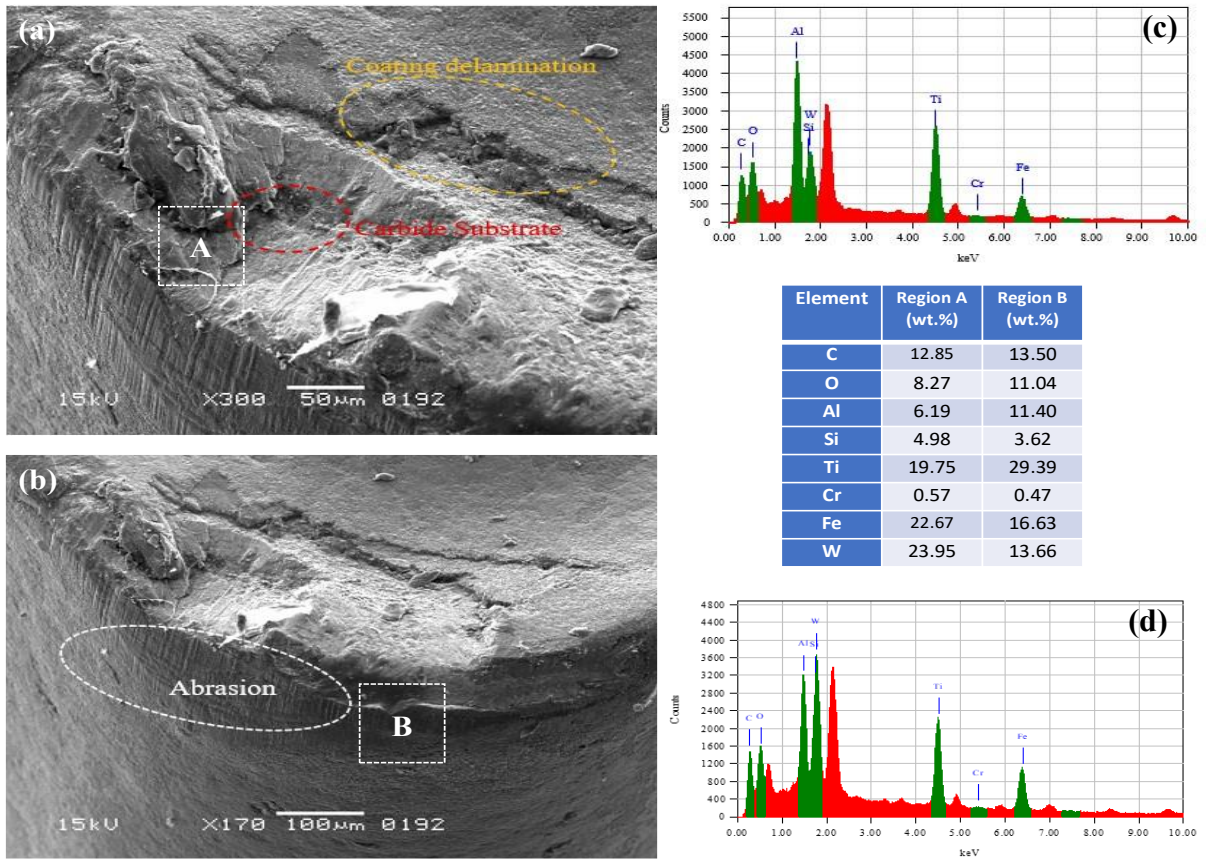
Fig. 18. SEM (a,b) and EDS (c,d) analysis on the worn tool at V = 60 m/min

At cutting speed 60 m/min SEM images Fig. 18(a) revealed coating delamination and parallel abrasion marks on the flank, indicative of abrasive wear and formation of grooves caused by hard metallic carbides in the steels [15]. EDS analysis (Fig. 18(b)) confirmed strong Al and Ti peaks from the tool coating, suggesting the protective layer remained largely intact. Minor Fe traces indicated slight workpiece material adhesion, and low Oxygen content ruled out significant oxidation. Consequently, small scale abrasion with coating delamination dominated at low cutting speeds in hard turning, aligning with prior research [34].

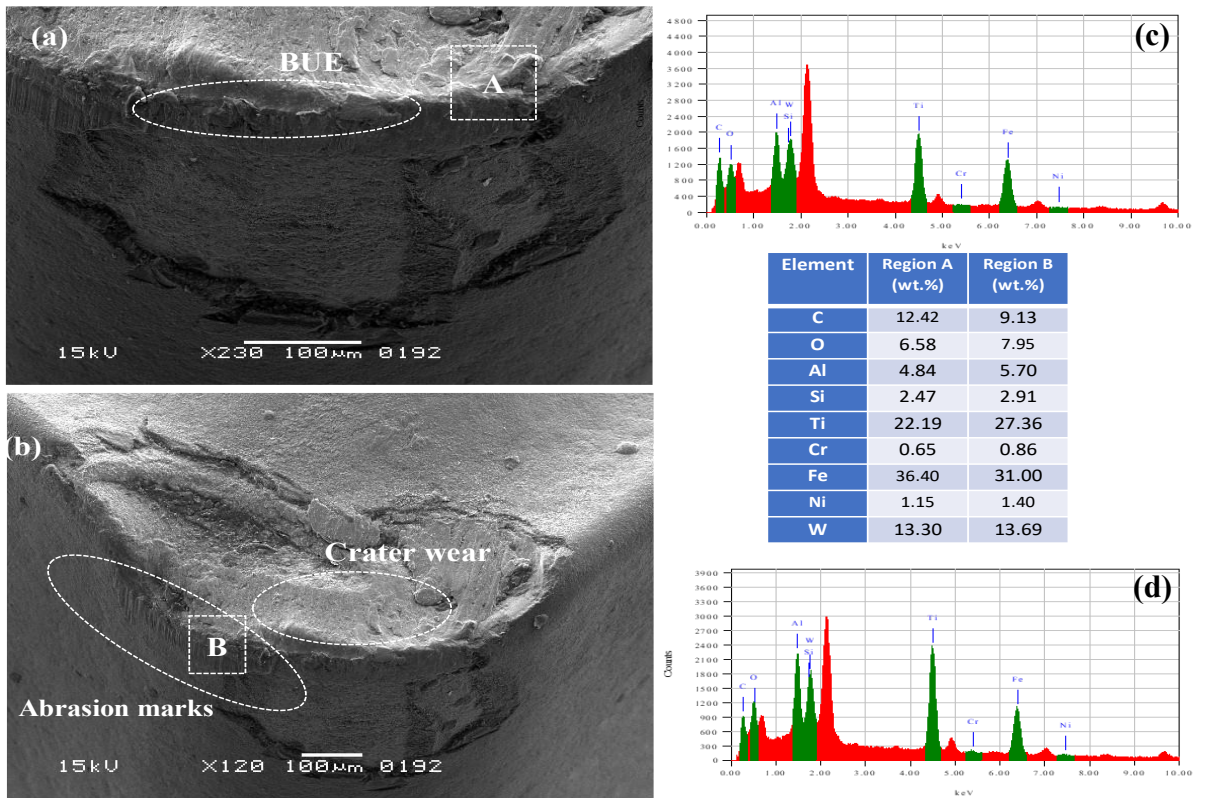
Fig. 19. SEM (a,b) and EDS analysis (c,d) on the worn tool at V = 95 m/min

At a cutting speed of 95 m/min, Fig. 19, SEM analysis revealed the formation of a built-up edge on the rake face, characteristic of adhesive wear during the hard turning [35]. EDS confirmed elevated Fe, Cr, and Ni transferred from the AISI 4340 workpiece. The progression of flank wear and repeated BUE, detachment indicates cyclic adhesion and tearing, corroborating existing research [36,37]. Although coating elements were still detected, at lower levels than at 60 m/min, indicating that the coating was not completely removed. Their reduced intensity indicated partial loss of the protective layer. adhesion and abrasion occur concurrently at this intermediate speed, with elevated temperatures accelerating material transfer.

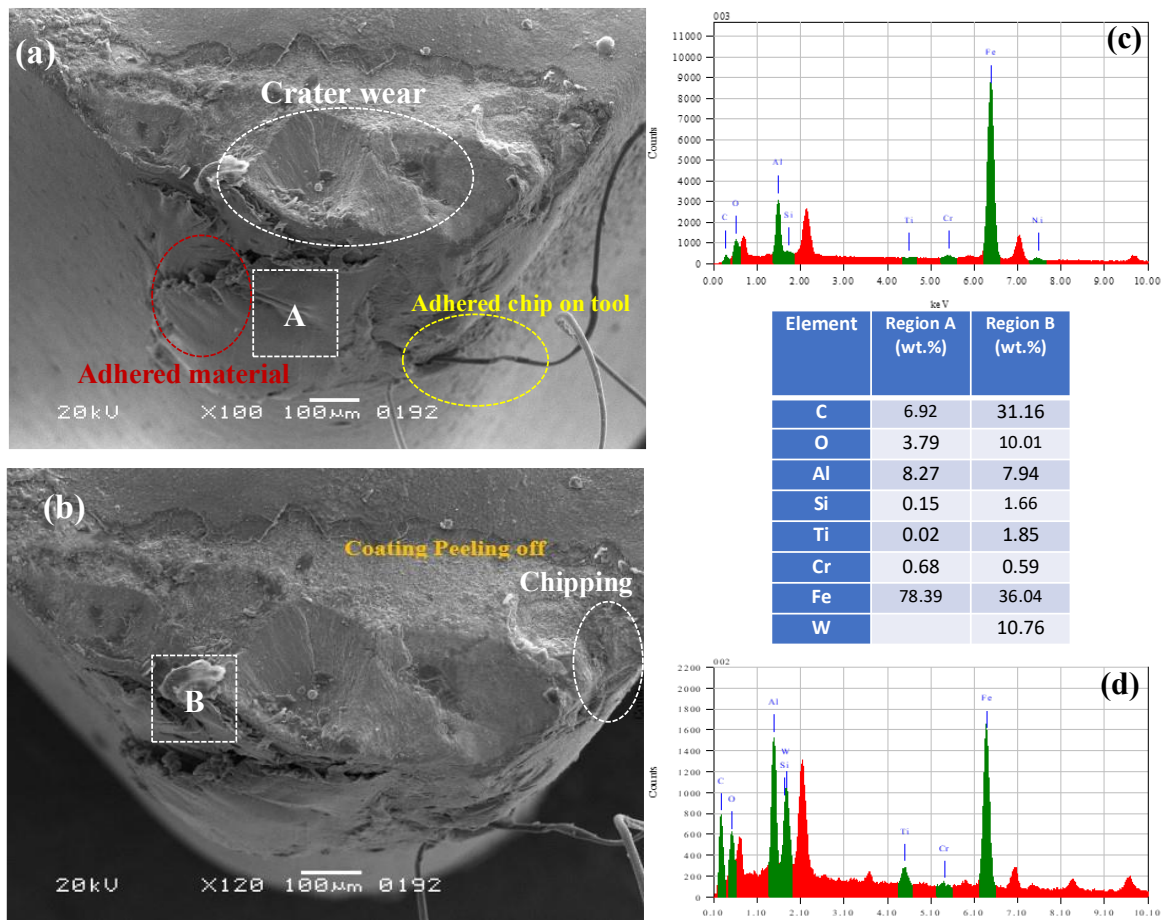
Fig. 21. SEM (a,b) and EDS analysis (c,d) on the worn tool at V = 250 m/min

At a cutting speed of 250 m/min, SEM examination revealed significant tool degradation, characterized by deep cratering, edge fragmentation, and considerable plastic deformation at the tool-chip contact zone. EDS analysis presented in Fig. 21 indicated substantial adhesion and oxidation, as evidenced by elevated Fe and O signals, also deep crater formation on rake face of tool is evident. EDS indicates reduced coating elements and increased Fe and O consistent with coating loss and oxidation signify the failure of the protective coating and exposure of the underlying substrate shows flaking. Furthermore, SEM imaging Fig. 21 captured adhered chip fragments fused to the rake face, which are prone to dislodgment, leading to the removal of both coating and substrate material. This mode of wear is a recognized phenomenon in the high-speed hard turning of steels [36,39].

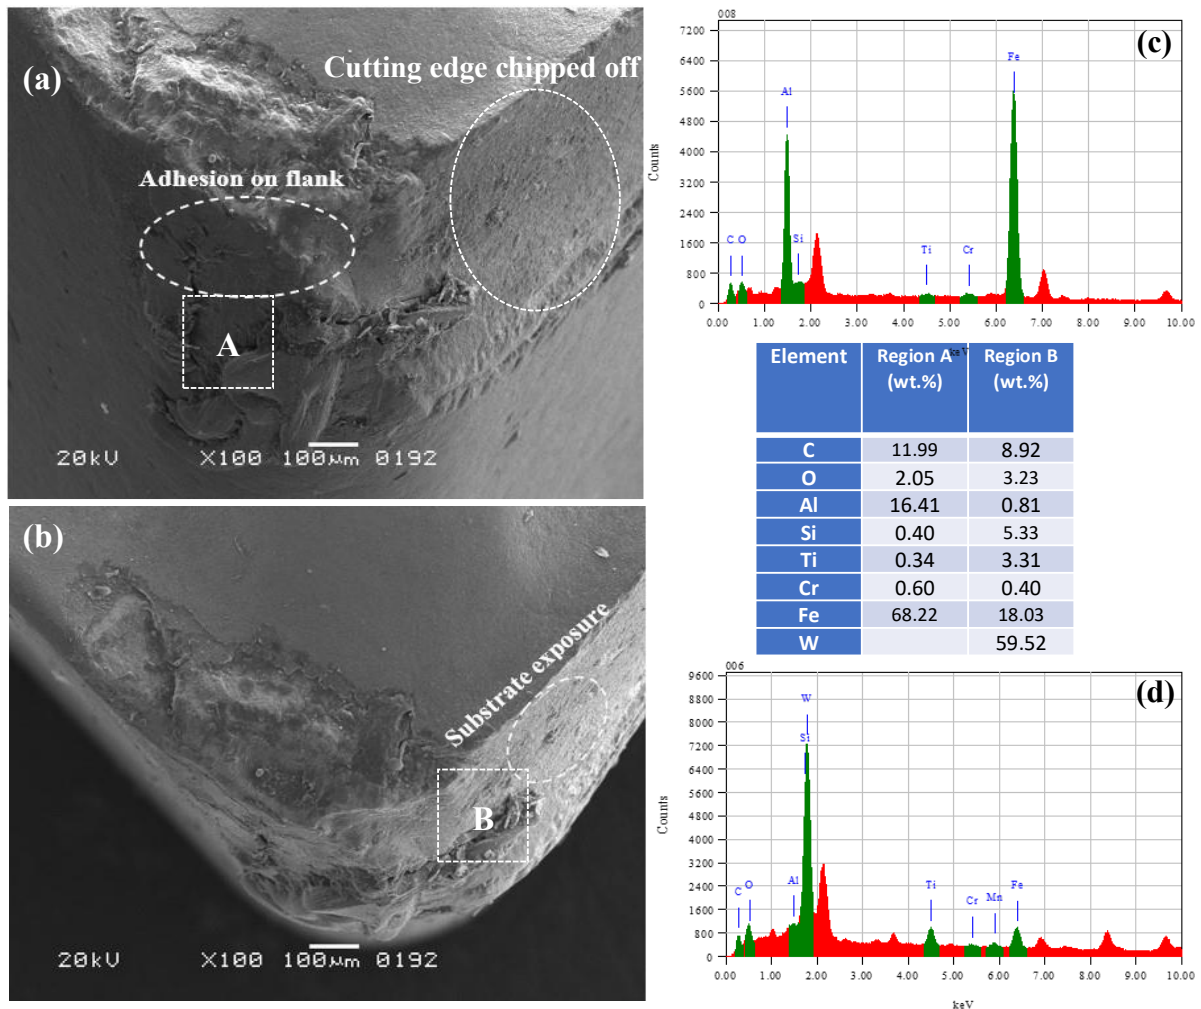
Fig. 22. SEM (a,b) and EDS analysis (c,d) on the worn tool at $V = 250$ m/min (wet)

Interestingly, at 250 m/min (with coolant), tool wear was surprisingly more severe. Although oxidation appeared slightly reduced, SEM images (Fig. 22) revealed catastrophic

coating spallation, edge chipping, and substrate exposure. EDS spectra confirmed strong Fe peaks (workpiece adhesion) and W signs the exposure of substrate. These results reveals that conventional cutting fluids were ineffective at controlling the extremely high temperatures in high speed hard turning, leading instead to accelerated flaking and rapid tool failure [32,40].

3. Under flood-cooling condition, higher wear was observed at 250 m/min compared to dry cutting. SEM/EDS revealed increased spallation and adhered workpiece material, suggesting that coolant boiling and ineffective interface cooling may contribute to coating failure in this condition. Further testing with alternative cooling/lubrication strategies is required to confirm the generality of this observation.
